UT-IG - Tech. Report # 78

Technical Report #4
10 November 1983

Pueblo Viejo-Quixal Seismograph Network
7 May 1983 through 12 September 1983

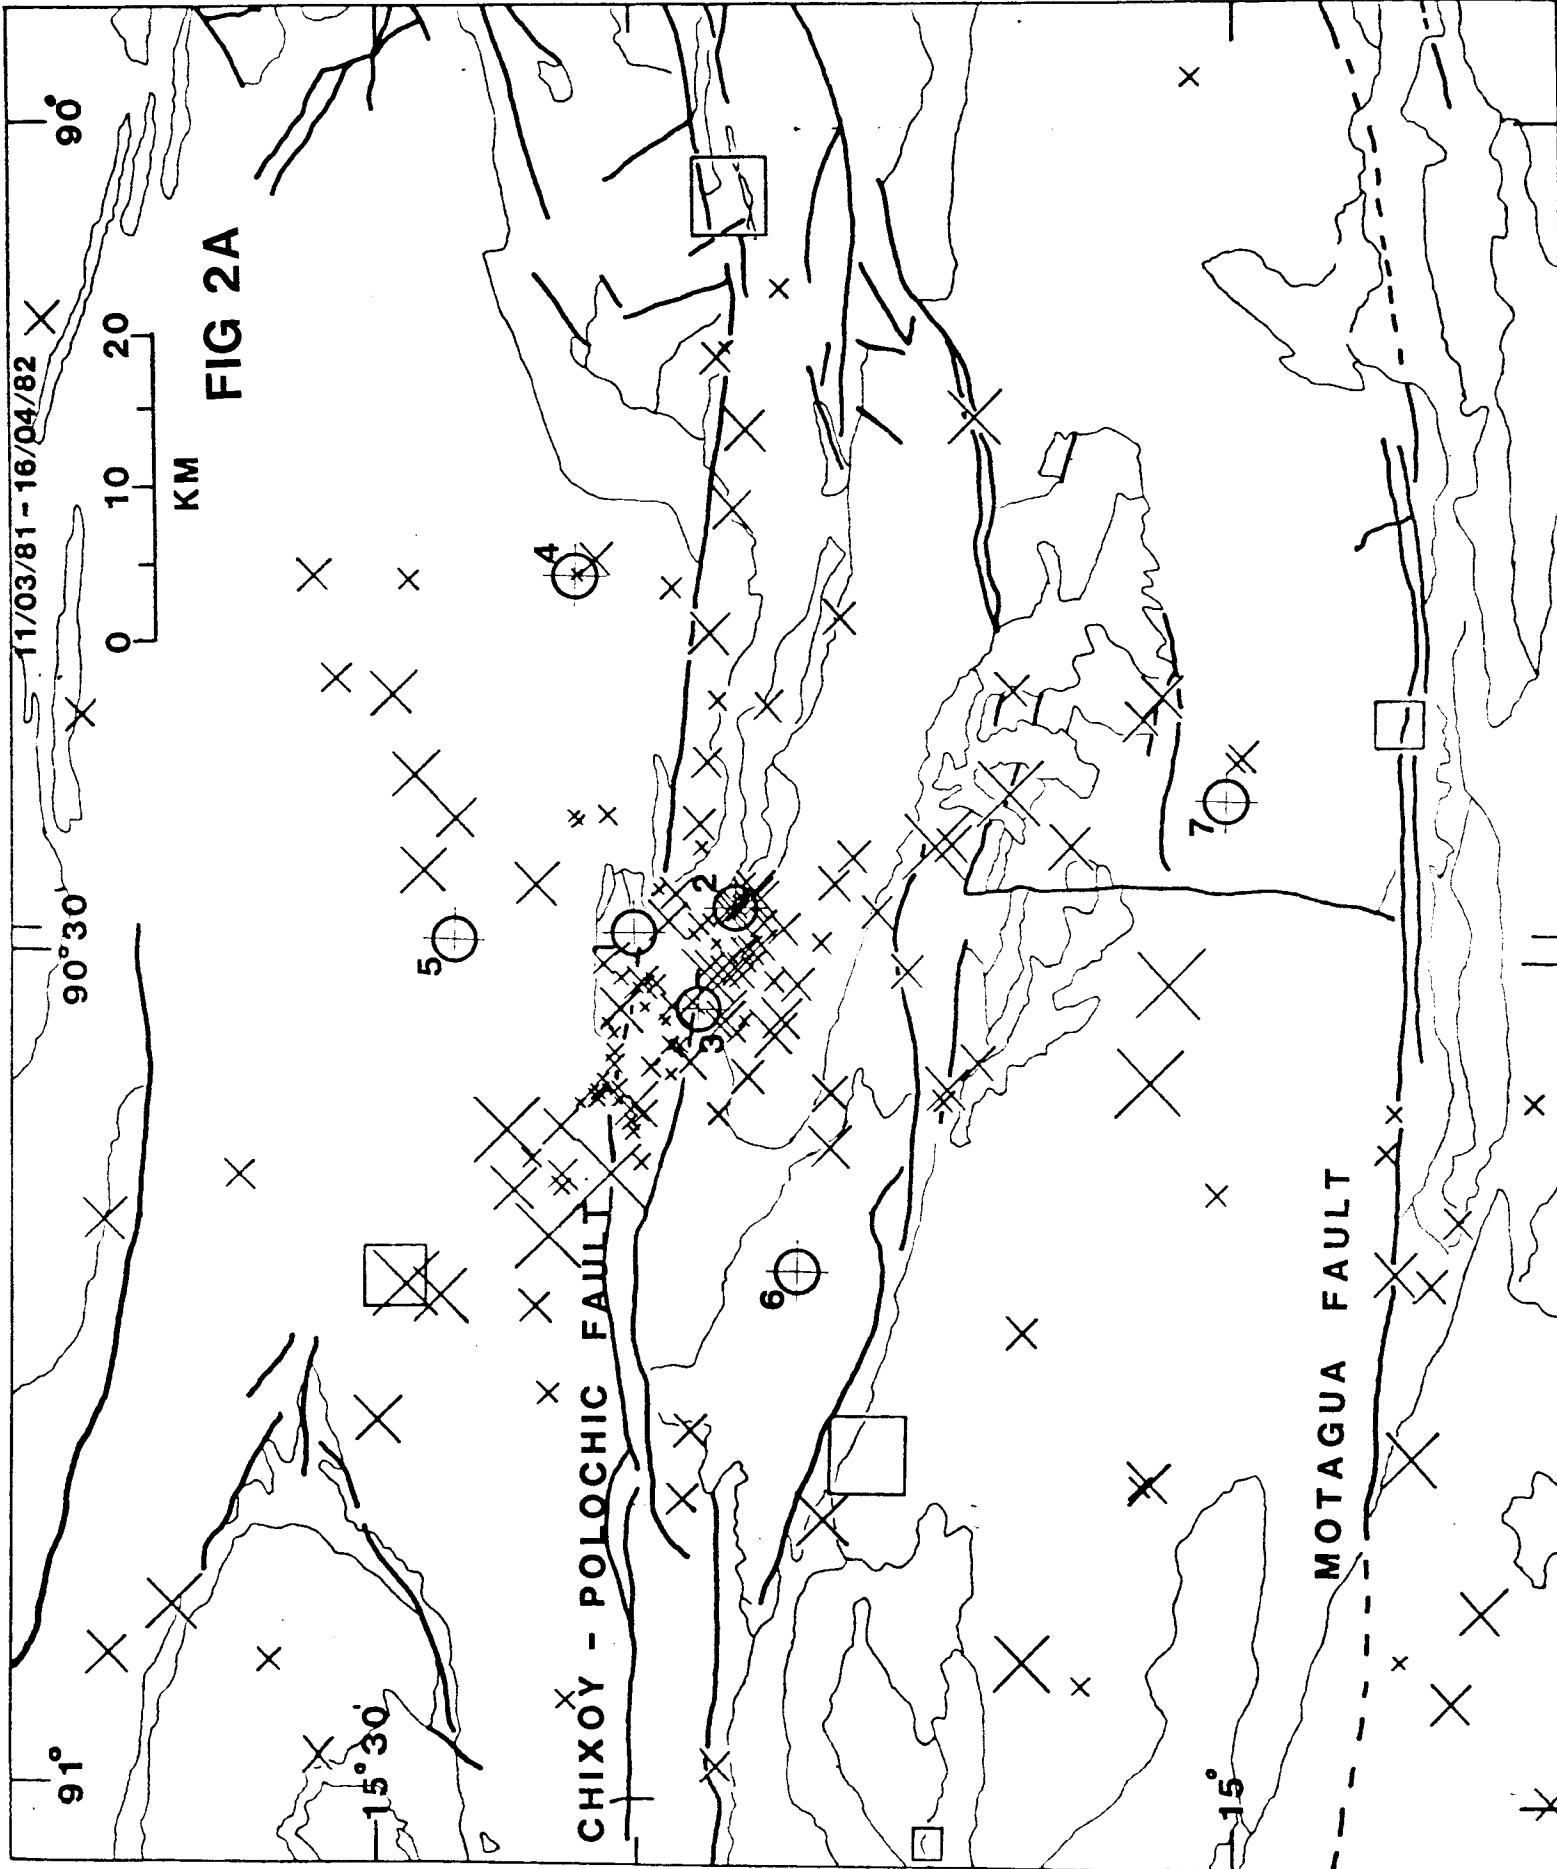
FIG 2A

2. Summary of Previous Work 1
 Fig. 2A Regional Seismicity
 Fig. 2B Composite Fault Plane Solutions
 of the events near the dam site
 Fig. 2C Distribution of earthquakes in
 the vicinity of Pueblo Viejo Dam
 27 Jan. 83 - 6 May 83

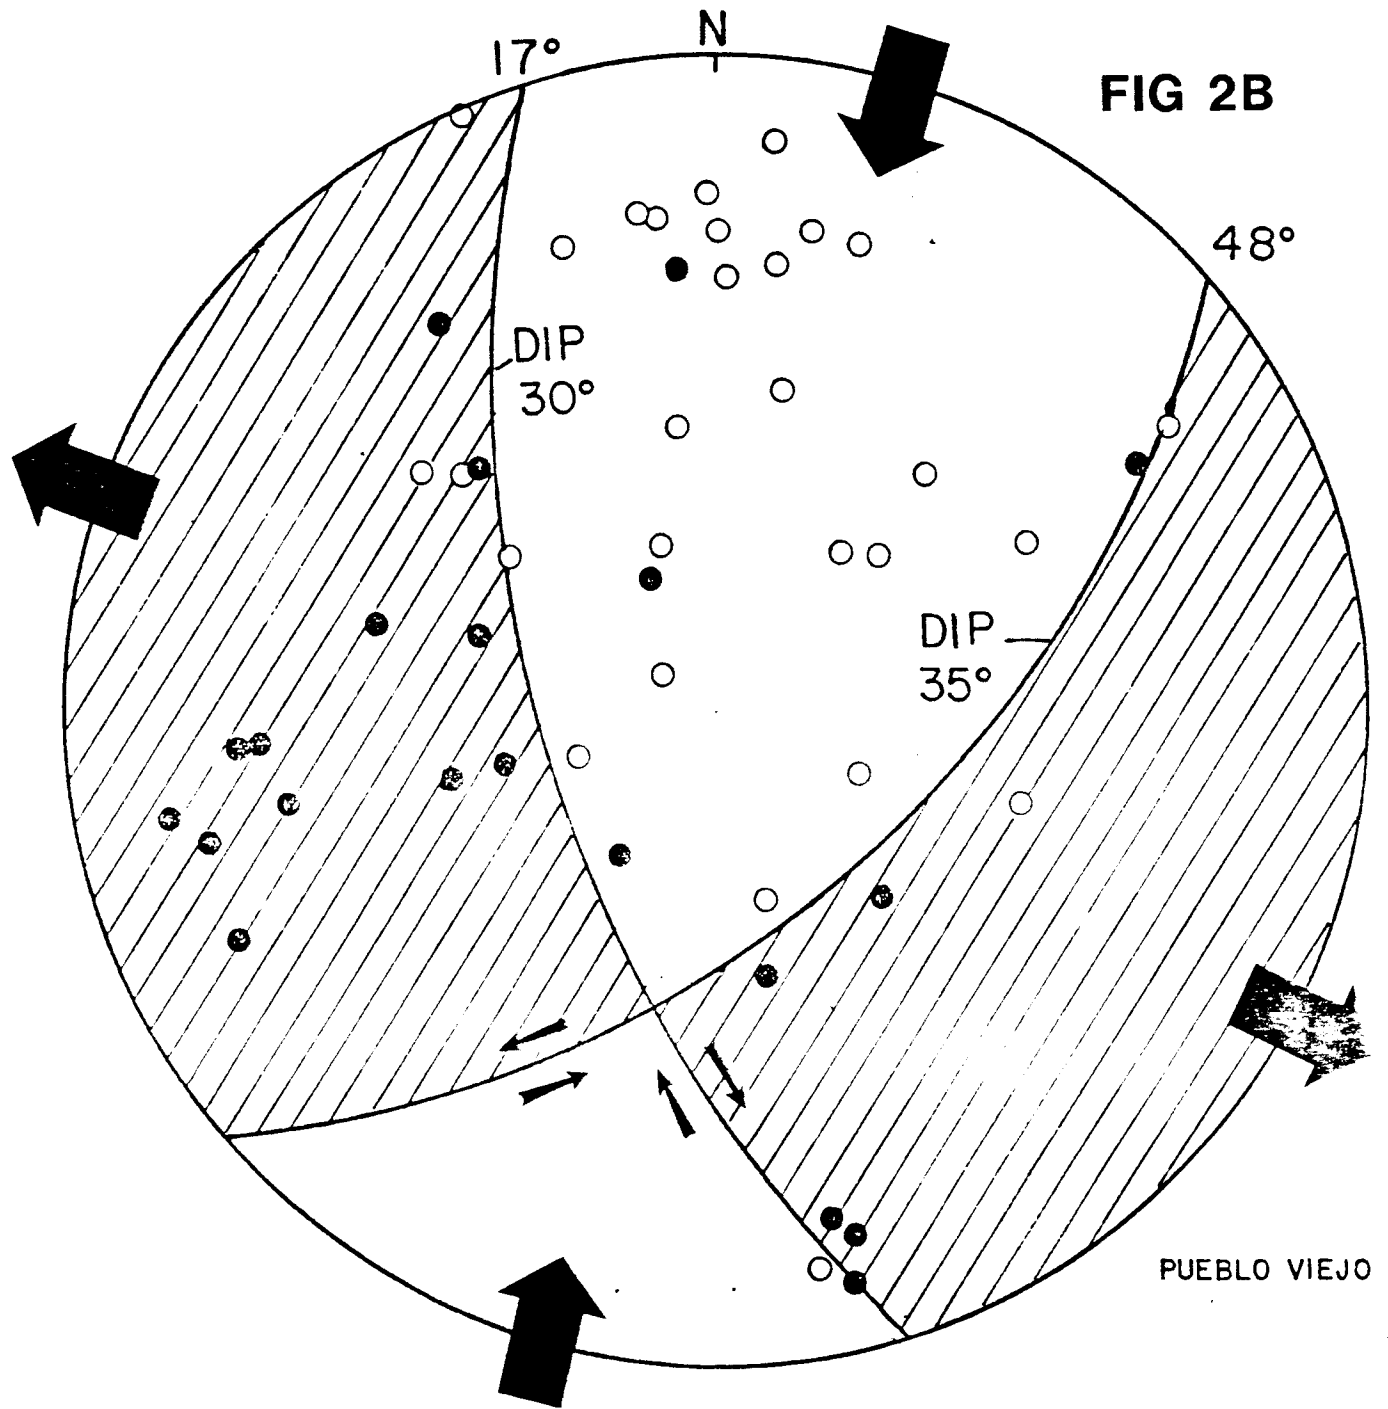
Fault Plane #1	Strike N17°W	Dip 30°E
Fault Plane #2	Strike N48°E	Dip 35°NW

These solutions are approximately in agreement with the stress field consisting of north-south compression and east-west tension. Such a stress is interpreted as the consequence of the regional plate motions; namely, northward thrust of Cocos plate and westward movement of the Caribbean plate, or differential shear between the CCP fault and the Motagua fault.

Figure 2B. Composite fault plane solution for the events in the vicinity of Pueblo Viejo Dam.

Scantness of data prohibits us from identifying the fault plane solutions of water-induced earthquakes positively. But their fault plane solutions seem to be in general agreement with those shown in Figure 2B. This solution is akin to strike-slip but some element of normal to thrust faulting is present.

As contrasted to the fault plane solutions for earthquakes located near the dam site (Figure 2B), one of the fault planes shown in Figure 6B is almost parallel to east-west trending CCP fault. It is not known whether an increase of pore pressure would trigger a major earthquake along CCP fault or not.

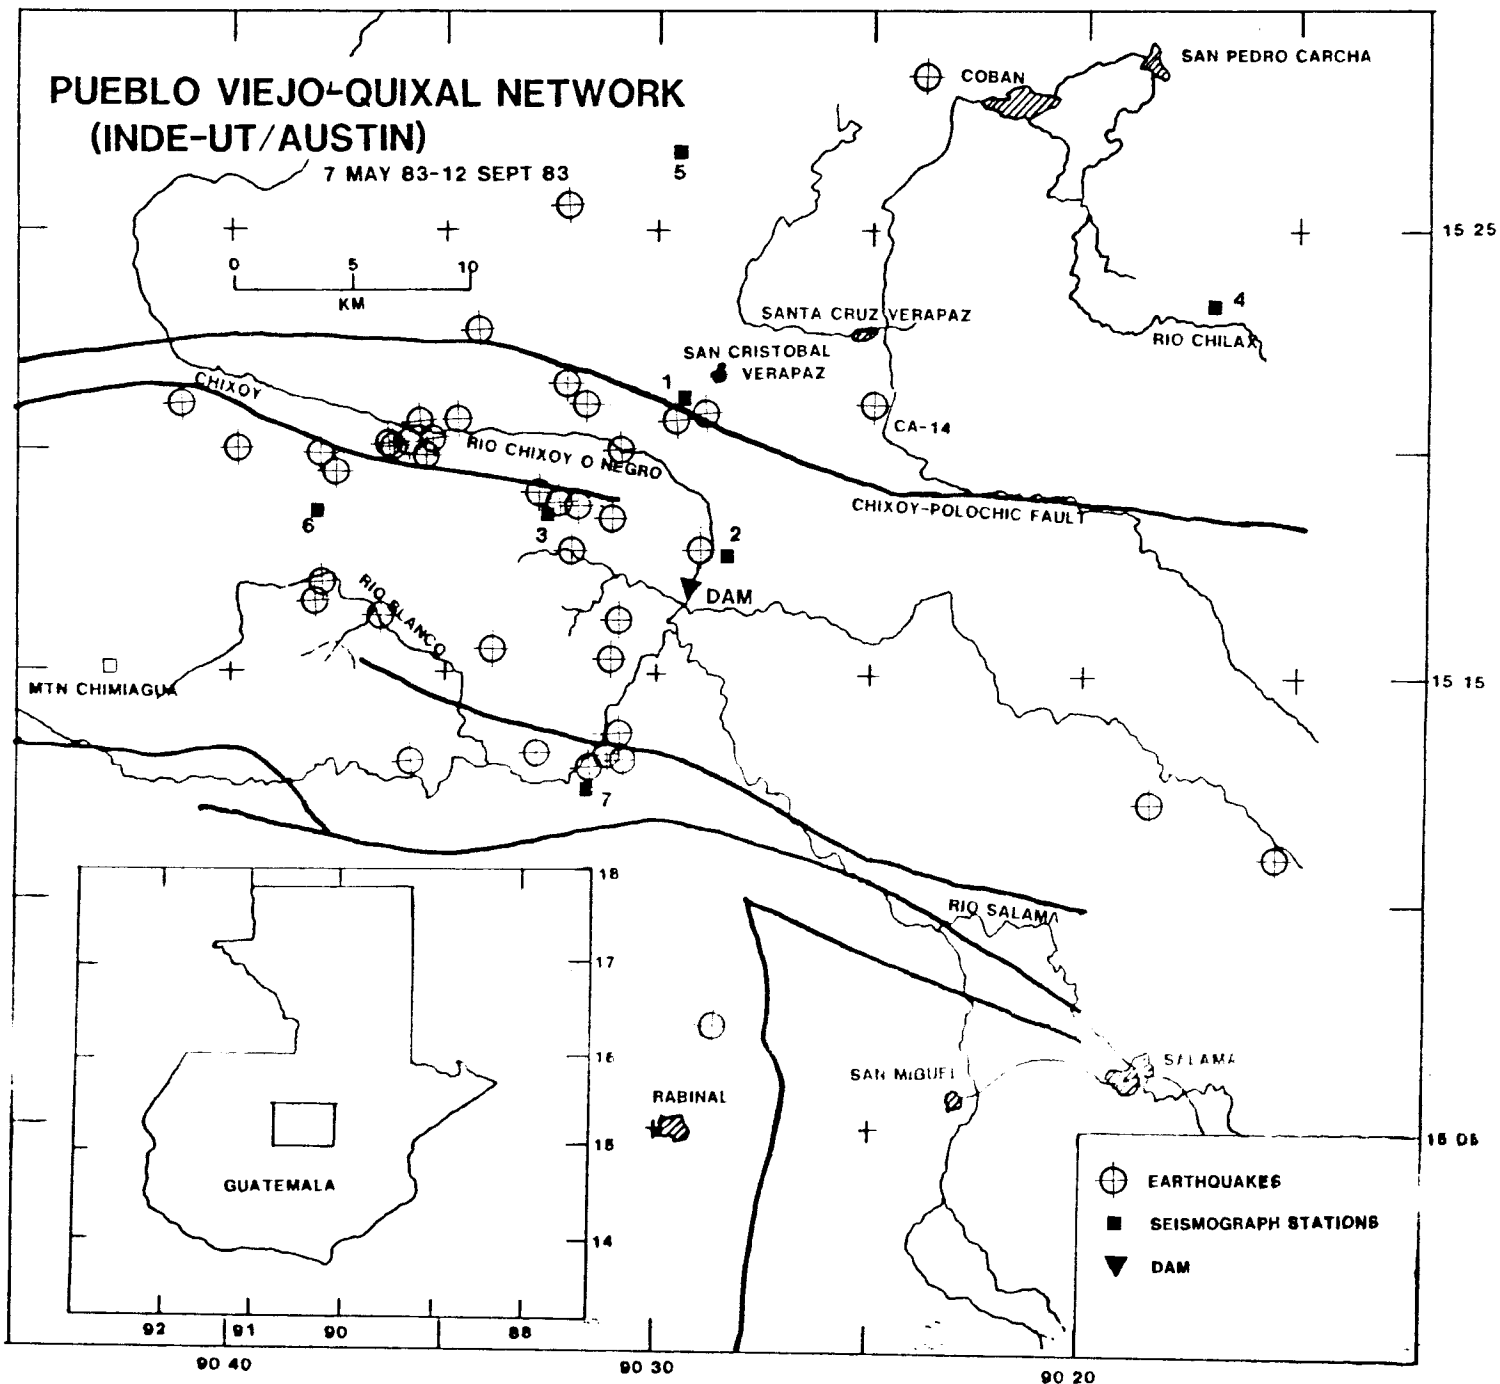
FIG 4A

The origin time, latitude, longitude, depth, magnitude, root mean square error, error in horizontal and vertical direction are listed in Table 1. Of earthquakes listed in Table 1, those with large error were discarded and only the events which were accurately located (RMS < 1.0) are plotted in Figure 4A.

Comparison of the epicenter plots shown in Figure 2C (27 January 1983 - 6 May 1983) and those from the current period (Figure 4A: 7 May 1983 - 12 September 1983) reveals significant contrast in the distribution of the earthquakes, especially near the reservoir.

During the first 5 months of 1983 (Figure 2C), the vicinity of the reservoir was characterized by a gap in events. During the following four month period from 7 May 1983 - 12 September 1983, however, 14 water-induced earthquakes were located along the reservoir. Another significant difference between these two figures was a marked increase of seismic activity along the Cuilco-Chixoy-Polochic fault system. As many as 22 events were located along the CCP fault in Figure 4A as compared to only 10 events situated along the fault in Figure 2C.

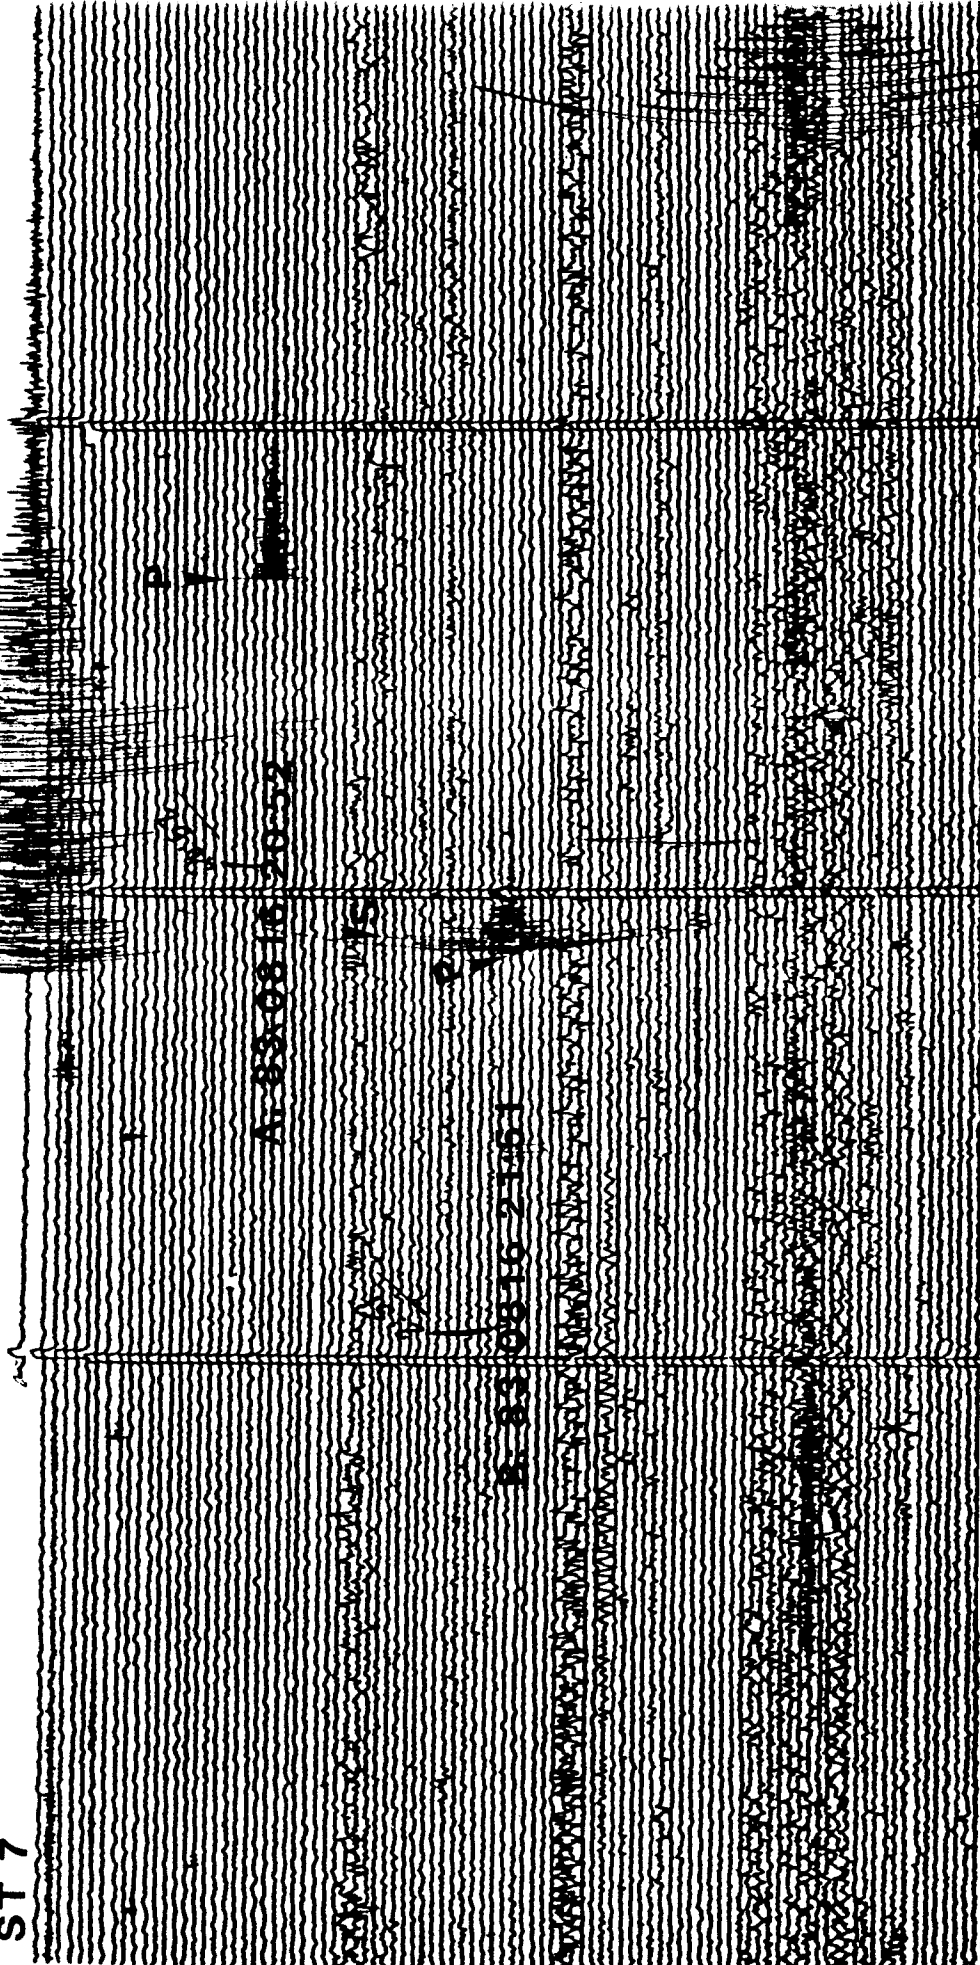
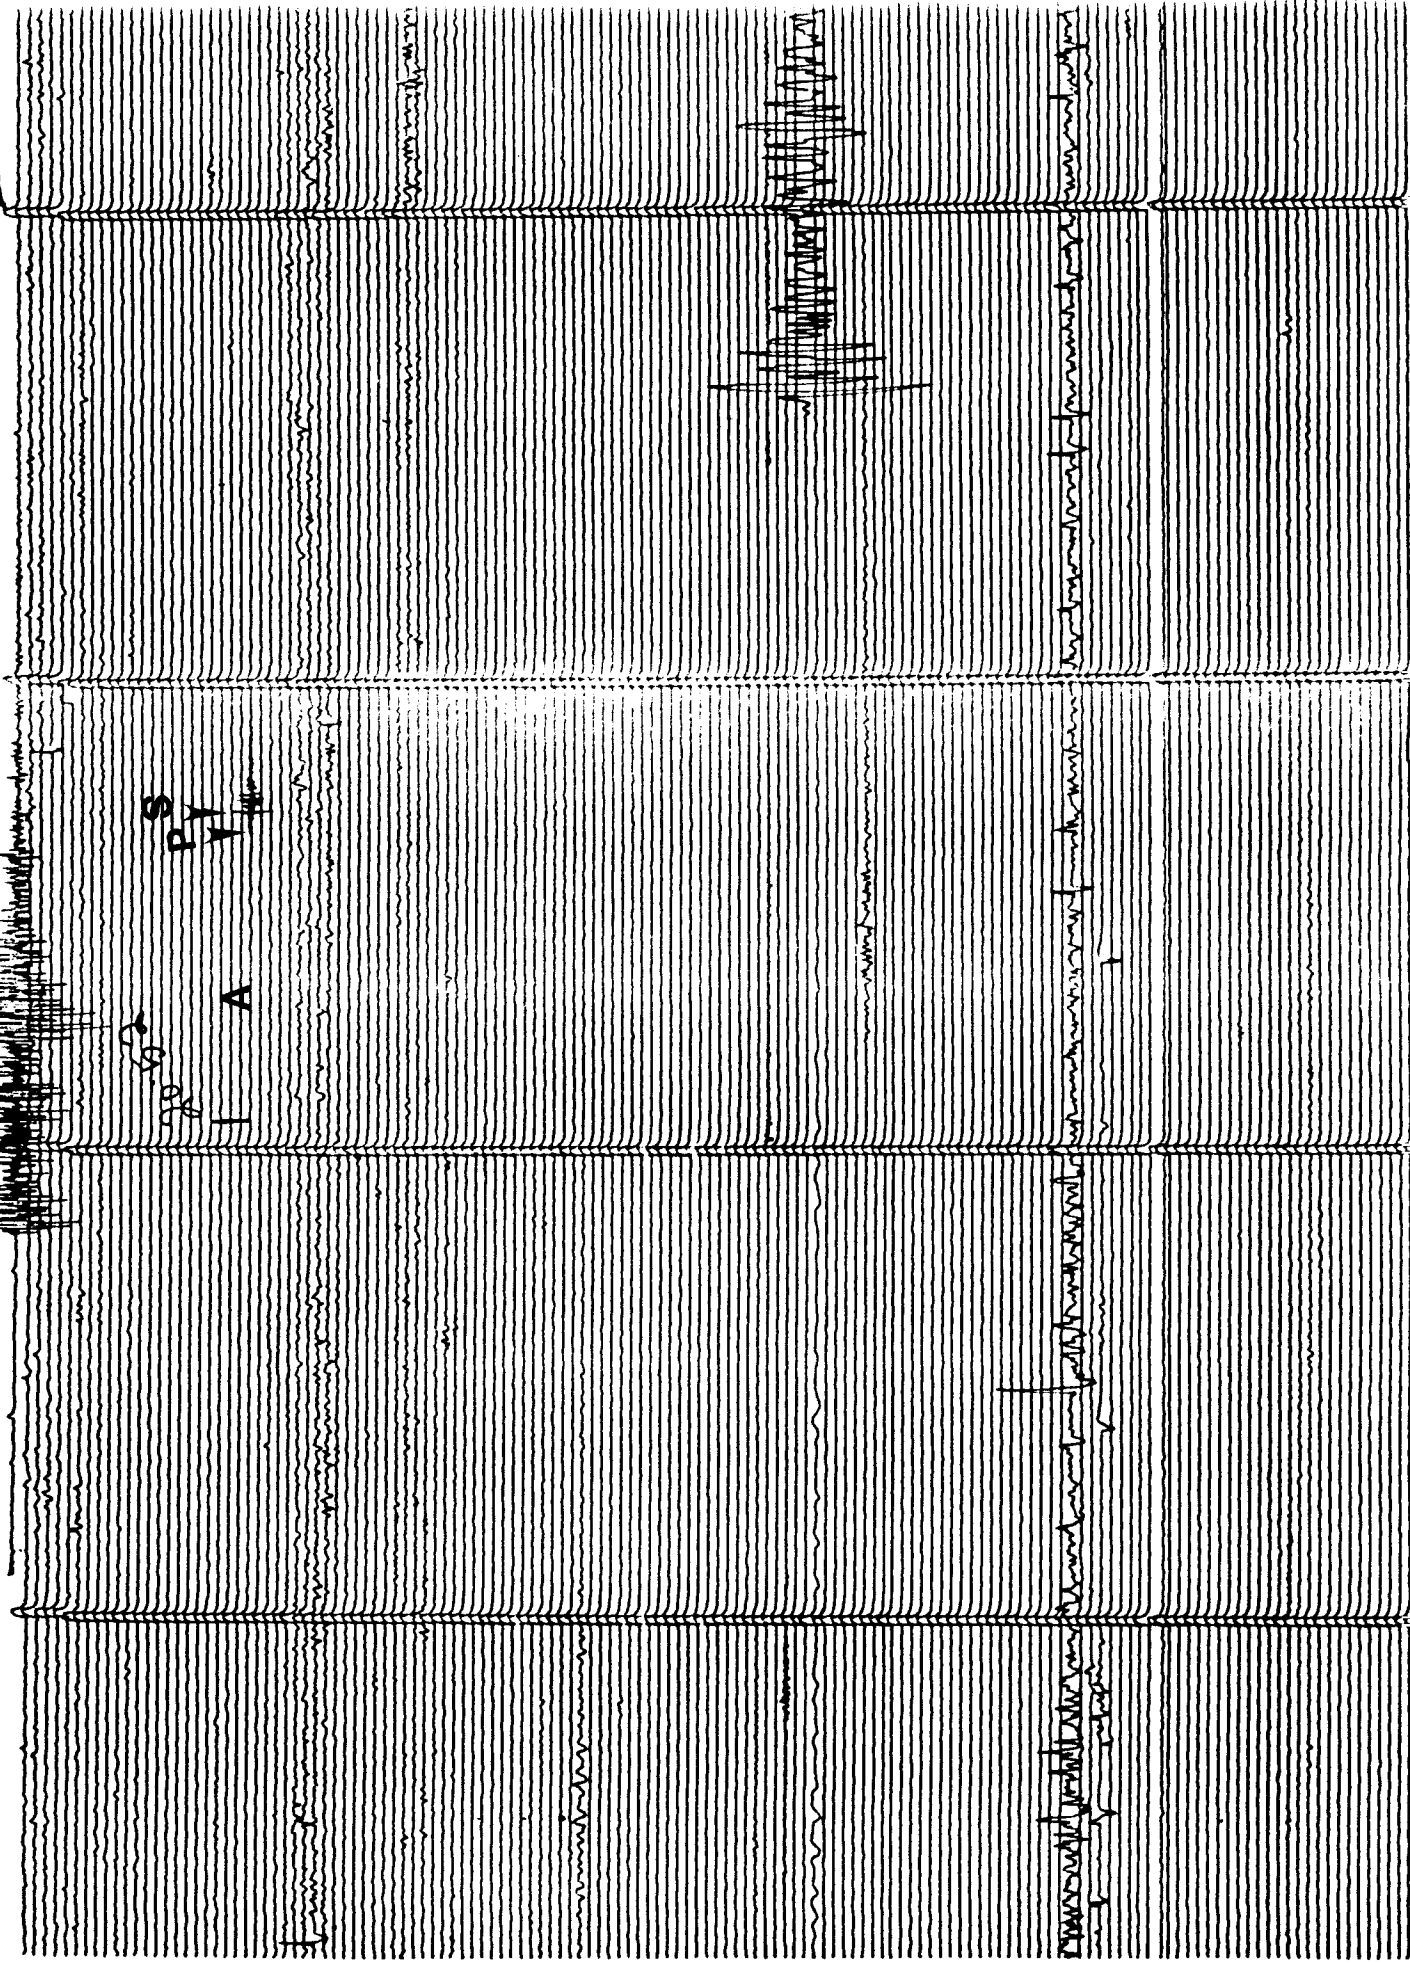
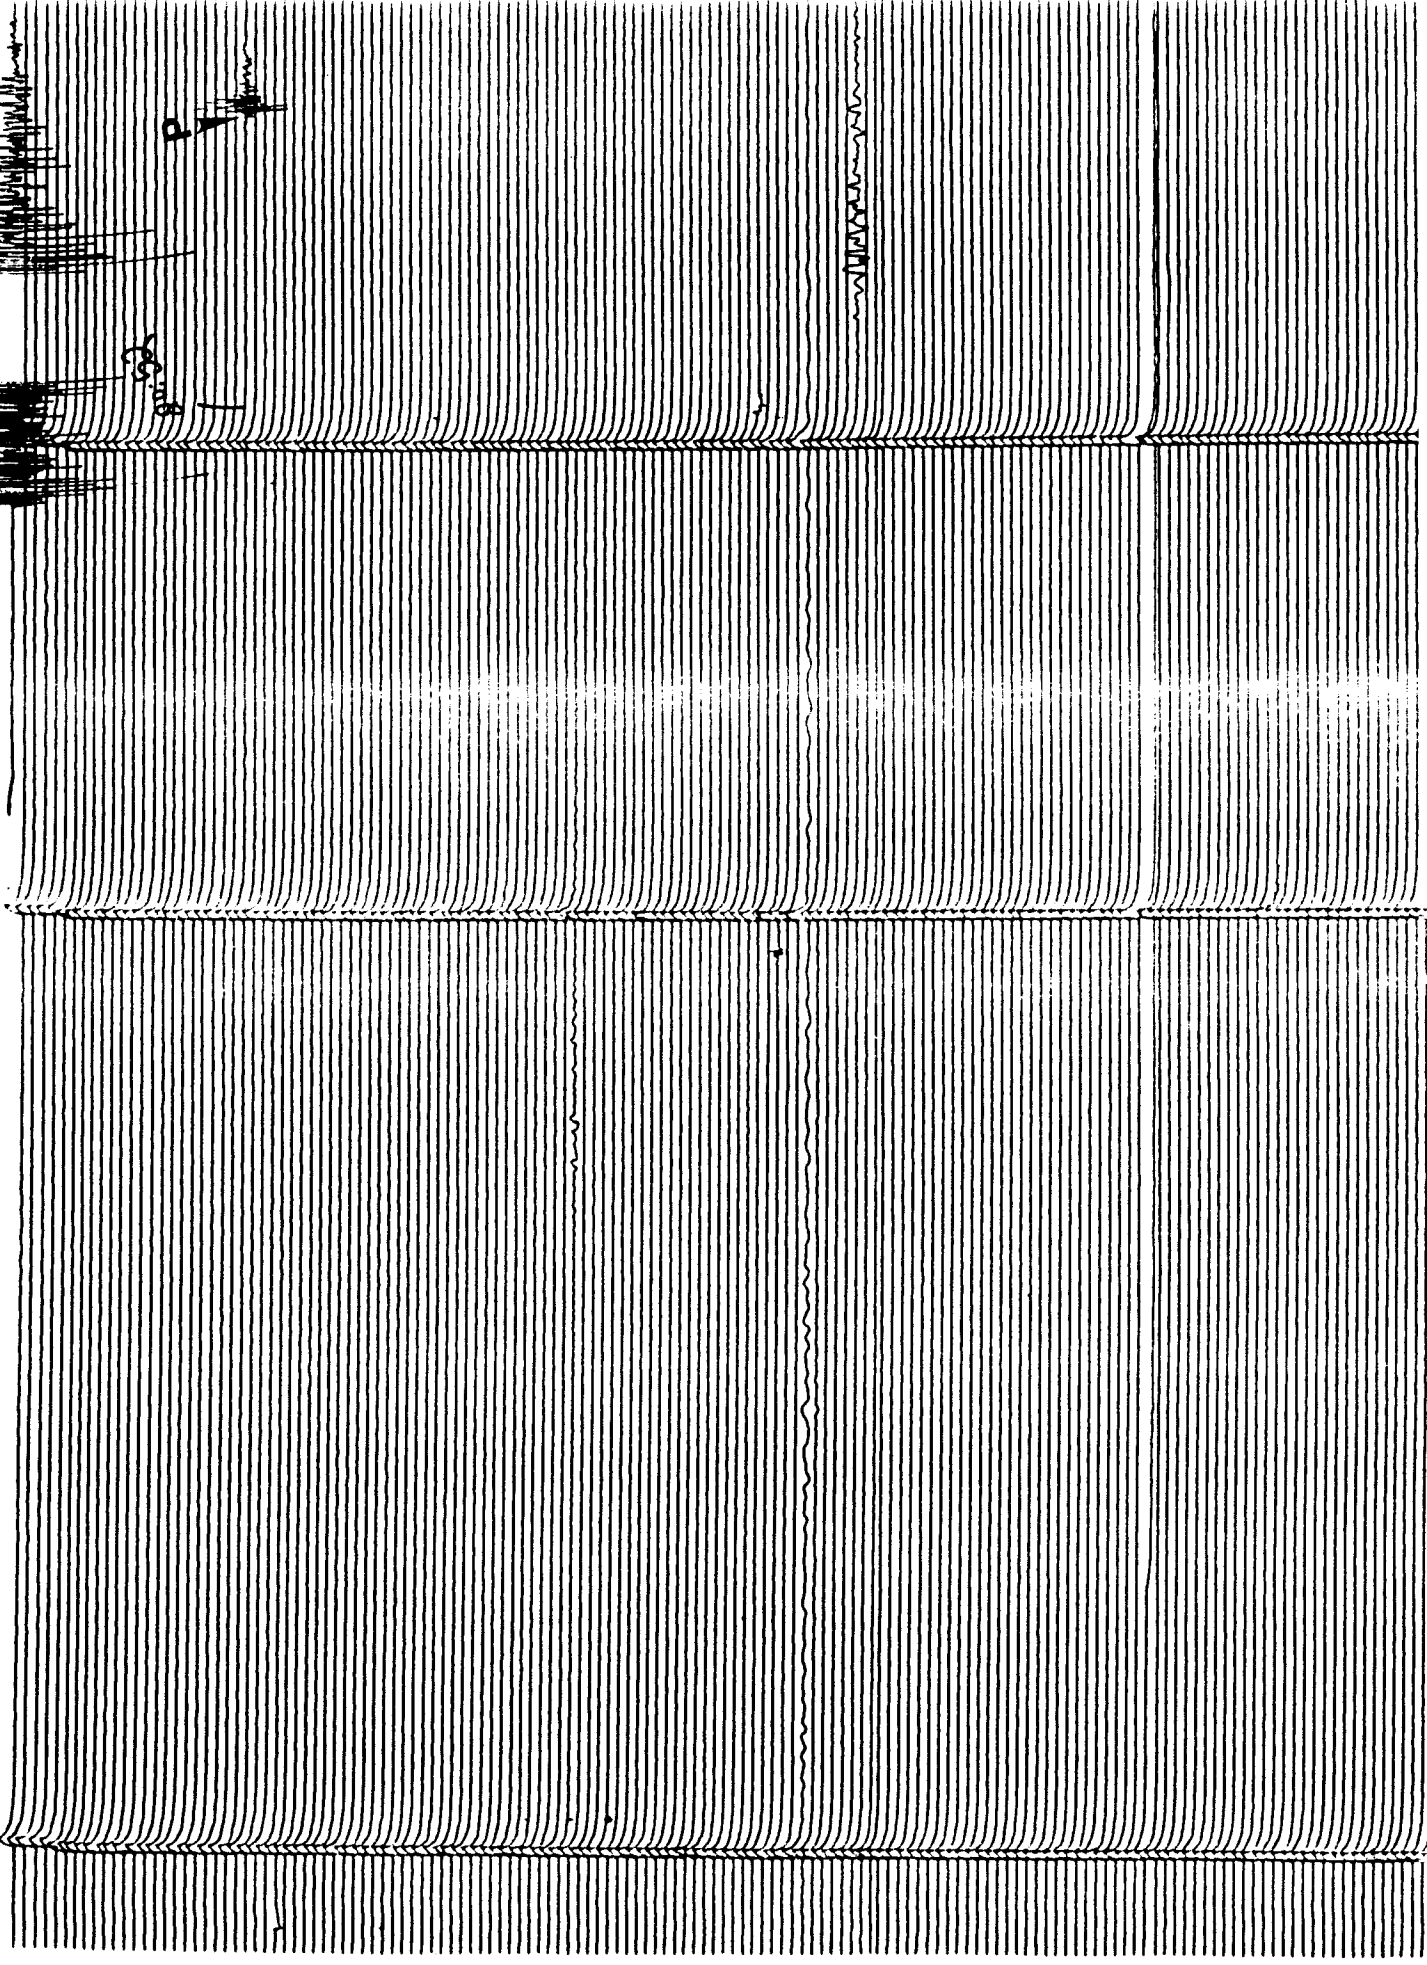
Some typical seismograms of water-induced earthquakes were selected and illustrated in Figure 4B. Characteristic seismic signatures for water-induced earthquakes are as follows:

- a) Short S-P time interval recorded by stations 1-3 and 6-7. Normally the S-P times registered at these stations are less than 2.0 seconds. The S-P time recorded at station 7 provides the most valuable insight.
- b) Large amplitude variation among the stations. Since the near-field amplitude attenuates rapidly as distance increases, the amplitudes registered at each station vary significantly. The majority of water-induced earthquakes were recorded only by stations 7 and/or 6.
- c) The arrival times to stations 4 and 5 are usually 1 - 2 seconds behind those of stations 1, 2, and 3, and the arrival time to station 1 is lagging from those of stations 2 and 3 by 1 - 2 seconds.

Figure 4B Seismogram of water induced earthquakes. There are two water induced earthquakes recorded in this chart:
A: 83 0816 20:52 and B: 83 0816 21:51
The event B is recorded at St 7 only, due to the fact that the event is located close to St 7. See the amplitude at St 7 is very large but the amplitudes at other stations became too small to be recorded.

Observation of such evidence facilitates identification of probable water-induced events even before epicenter determinations.

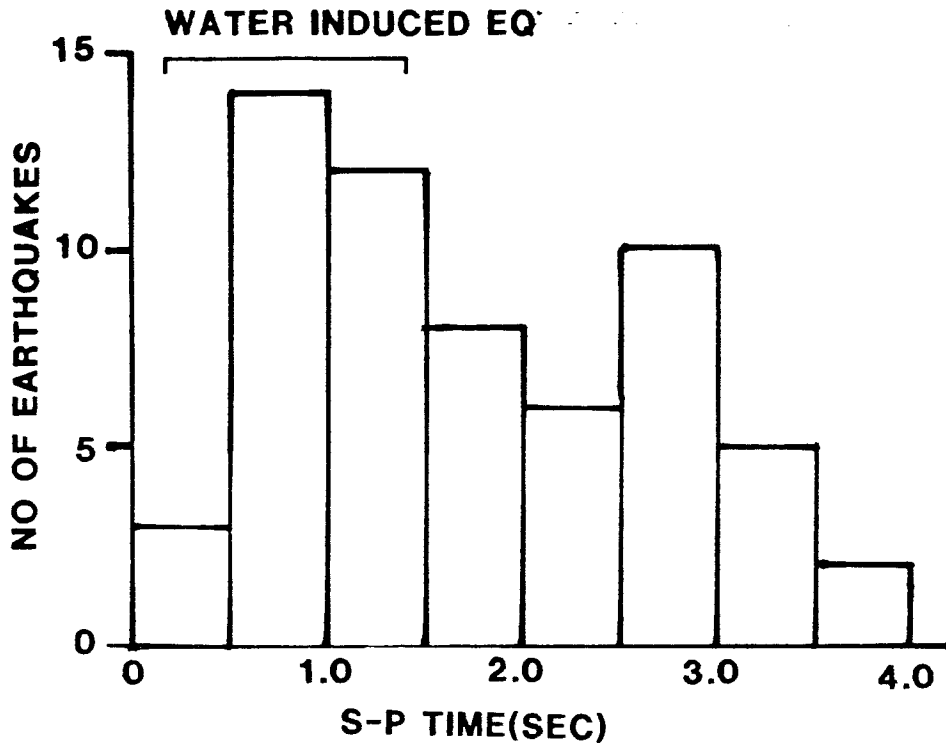
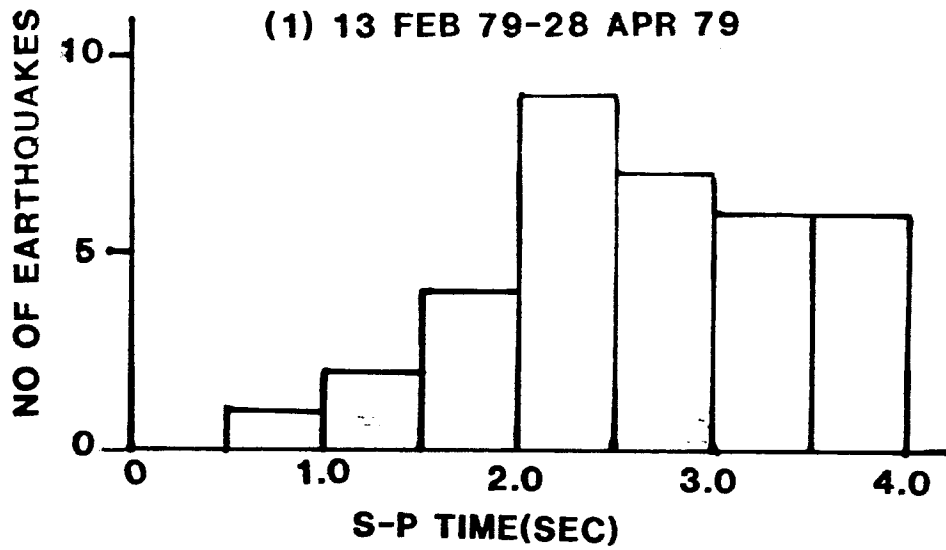
FIG 5A

To illustrate the change of the distribution of earthquakes, the histogram showing the number of earthquakes vs. S-P time interval was plotted in Figure 5A. Two separate time intervals: (1) from 13 February 1979 through 28 April 1979 and (2) from 7 May through 12 September 1983 were chosen. The former represents the pre-loading period and the latter is the second half of the loading period.

Station 7 was chosen because it is the closest station to the reservoir. Unfortunately station 7 was relocated between these two time periods, but the former was located only 3 km west of the latter and such a minute change does not significantly alter the general pattern of the histogram.

In the lower frame, which illustrates the histogram from 13 February 1979 - 28 April 1979, only 20 percent of the events (7 out of 35 events) were distributed within the S-P time interval shorter than 2.0 seconds. In the upper frame (7 March 1983 - 12 September 1983) 62 percent of the events (37 out of 60) were distributed within the S-P time interval shorter than 2.0 seconds. The peak distribution appearing between 0.5 and 1.5 seconds in the upper frame is apparently due to the distribution of water-induced earthquakes that emerged since 19 June 1983.

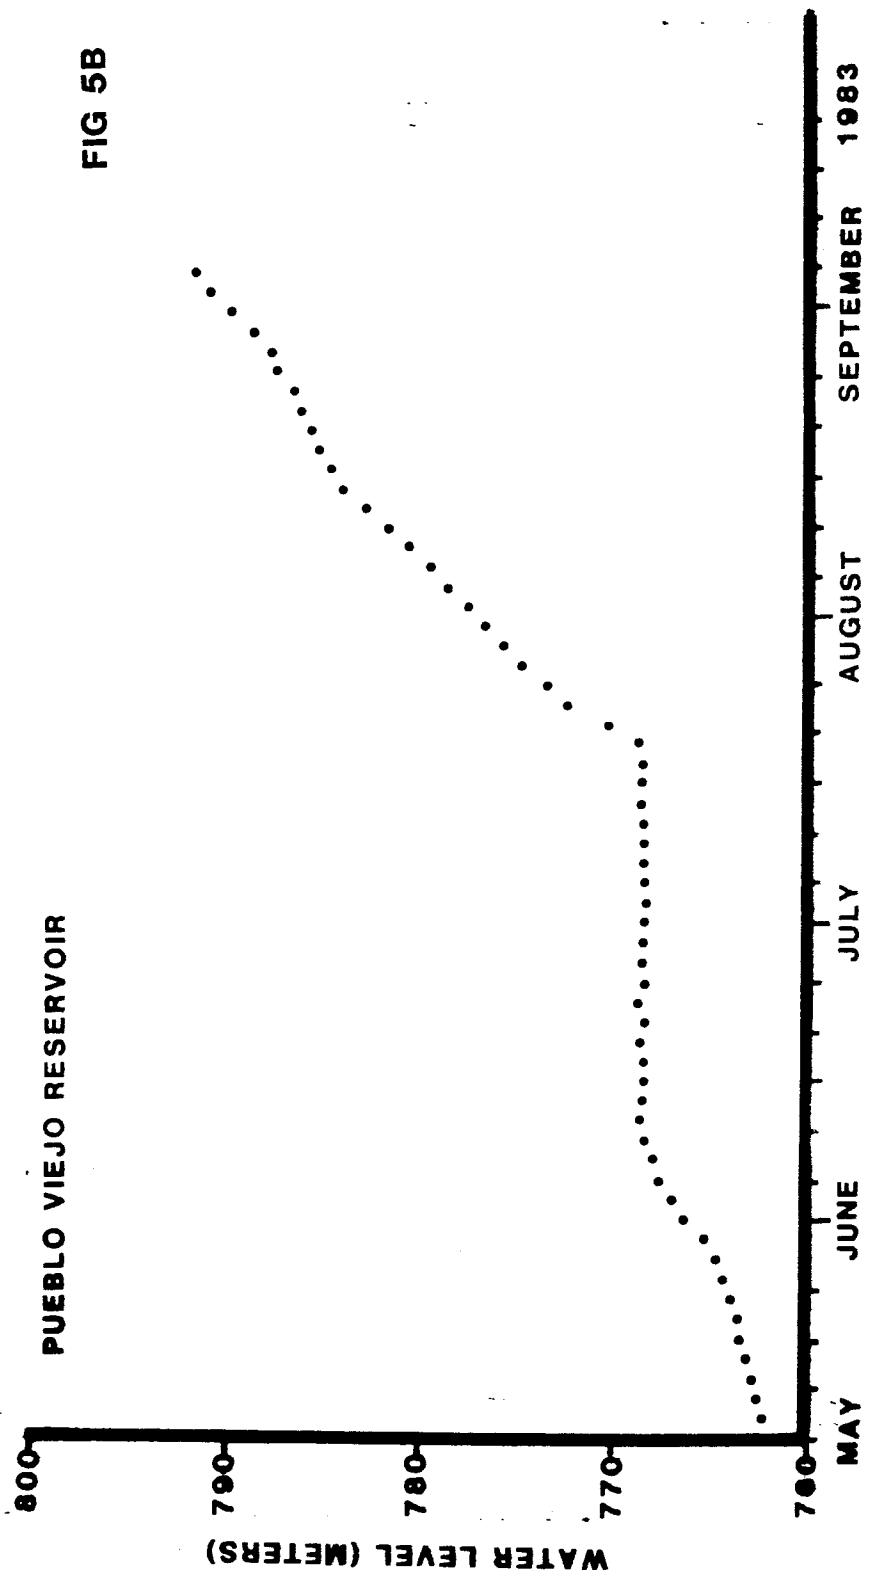
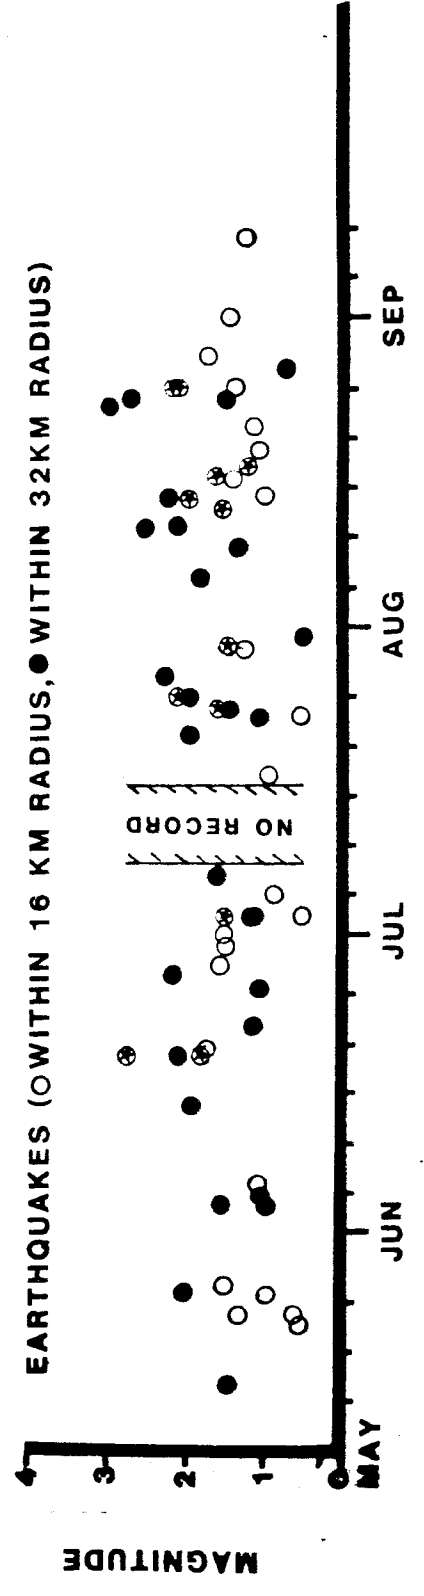
FIG 5B

The upper and lower frame of Figure 5B correlate the water level of the reservoir and recorded earthquakes, respectively. The earthquakes in the lower frame were plotted in two different symbols. Those occurring within a 32 km radius are shown by closed circles and those within a 16 km radius are indicated by open circles. Earthquakes located in the immediate vicinity of the reservoir were illustrated by an asterisk with an open circle.

It is noteworthy that the water-induced earthquakes located in the vicinity of the reservoir was first recognized on June 19, 1983 (Table 1). These events occurred during the prolonged period of constant water level at 769 m. The beginning of water-induced earthquakes during this stable elevation provides a clue to examine the mechanism of water induced earthquakes.

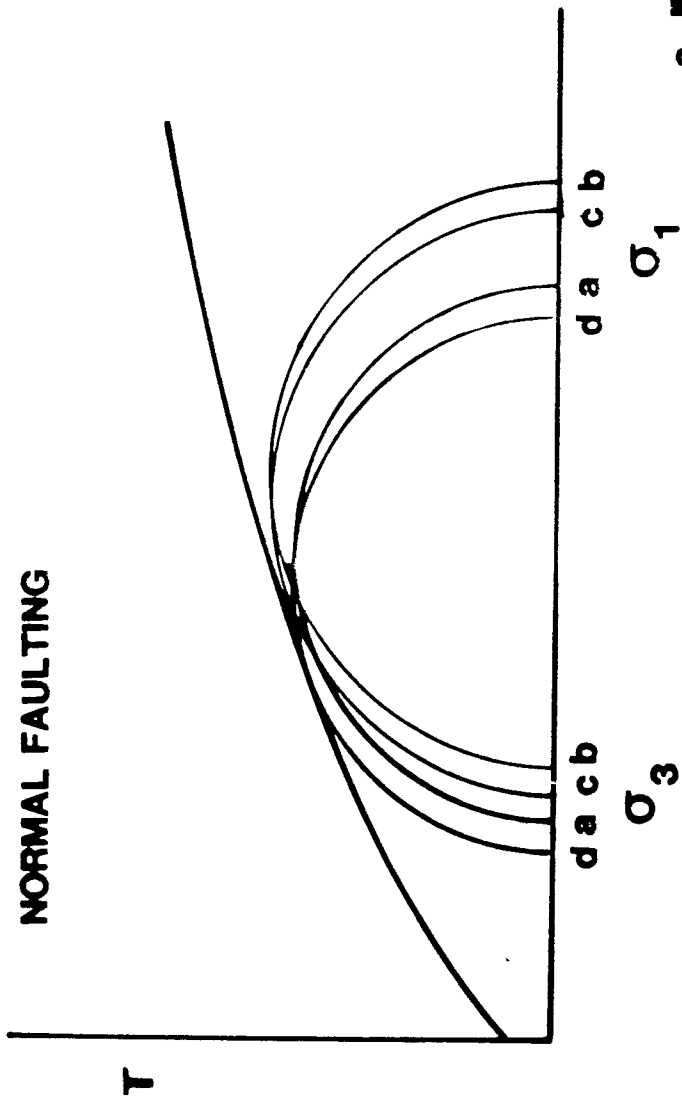
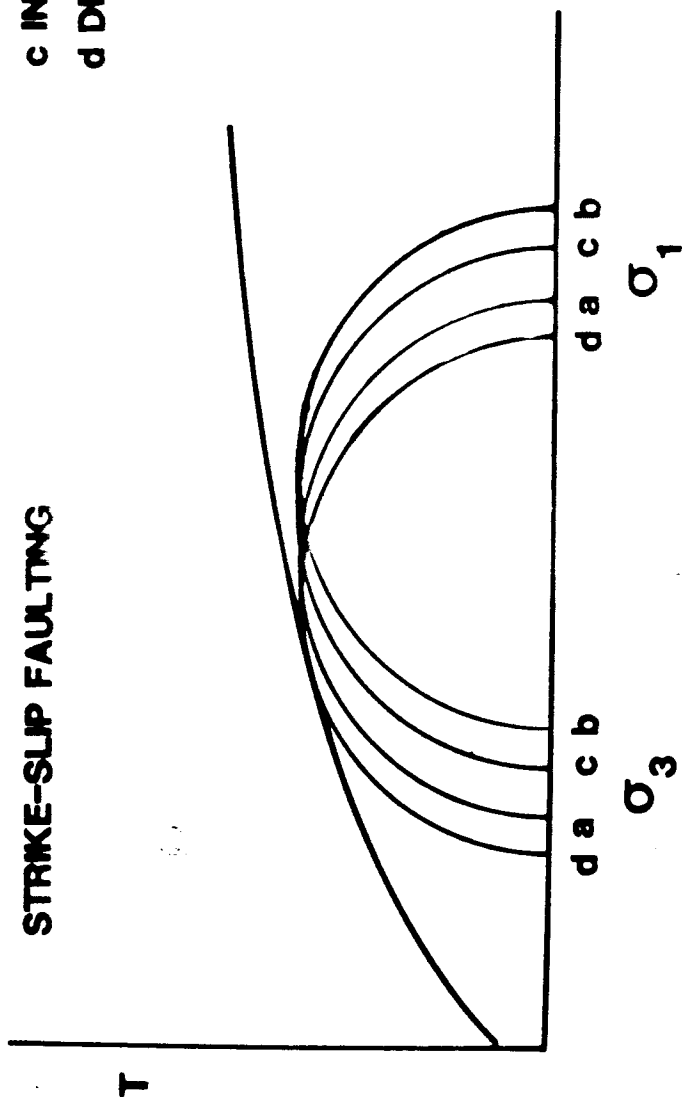
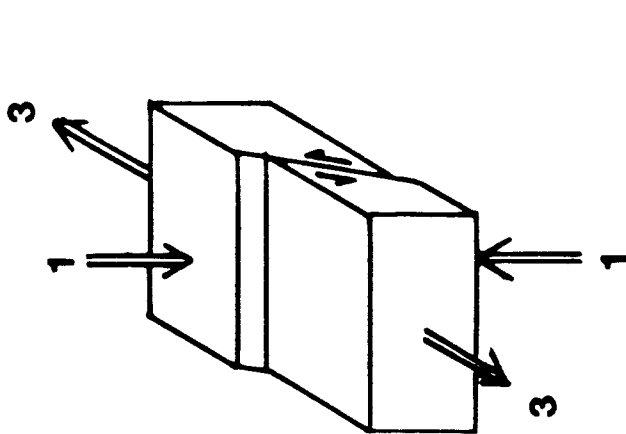
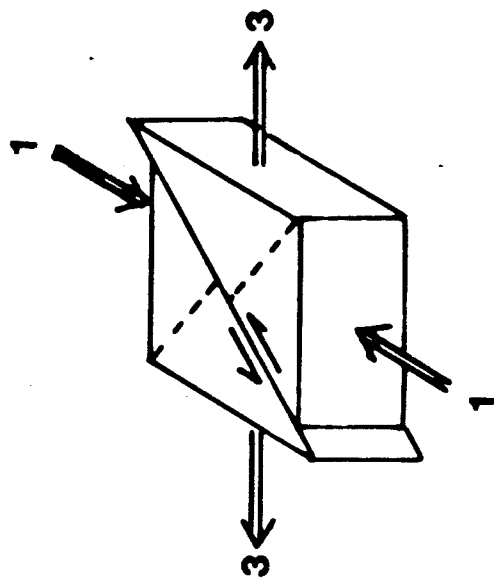
FIG 5C

A Mohr diagram in which shear stresses τ are plotted versus principal effective stress σ_e is drawn in Figure 5C for strike-slip faulting and normal faulting. The failure occurs when Mohr's circle becomes tangential to the Navier-Coulomb failure criterion curve. The orientation of principal stresses associated with the mode of faulting are indicated to the right-hand frame of Figure 5C.

- a INITIAL
- b INCREASE OF NORMAL STRESS
- c INCREASE OF PORE PRESSURE
- d DECREASE OF NORMAL STRESS

As the water level increases, both the normal stress σ_n and the pore pressure P increases. Figure 5C shows the Mohr's circles for four different circumstances. The circle a-a represents the initial stage, and moves to b-b after the increase of water level. Increased pore pressure moves the Mohr's circle to c-c but pore pressure P propagates gradually by diffusion and this change occurs with some time lag.

If the level of reservoir water remains at a constant elevation, the Mohr circle never becomes tangential with the fracture criterion curve for strike-slip environment, but under normal to thrust environment, the Mohr circle may become tangential with the fracture curve due to expanded radius of the Mohr circle.

If a fast draw-down of reservoir water moves the Mohr circle from c-c to d-d, fracture occurs under strike-slip environment as well as normal to thrust type environment.

Due to the presence of a major strike-slip fault system nearby, it is worthwhile to seriously consider avoiding rapid draw-downs from the Pueblo Chixoy reservoir.
