UT-IG - Tech. Report # 78

Technical Report #4
10 November 1983

Pueblo Viejo-Quixal Seismograph Network
7 May 1983 through 12 September 1983

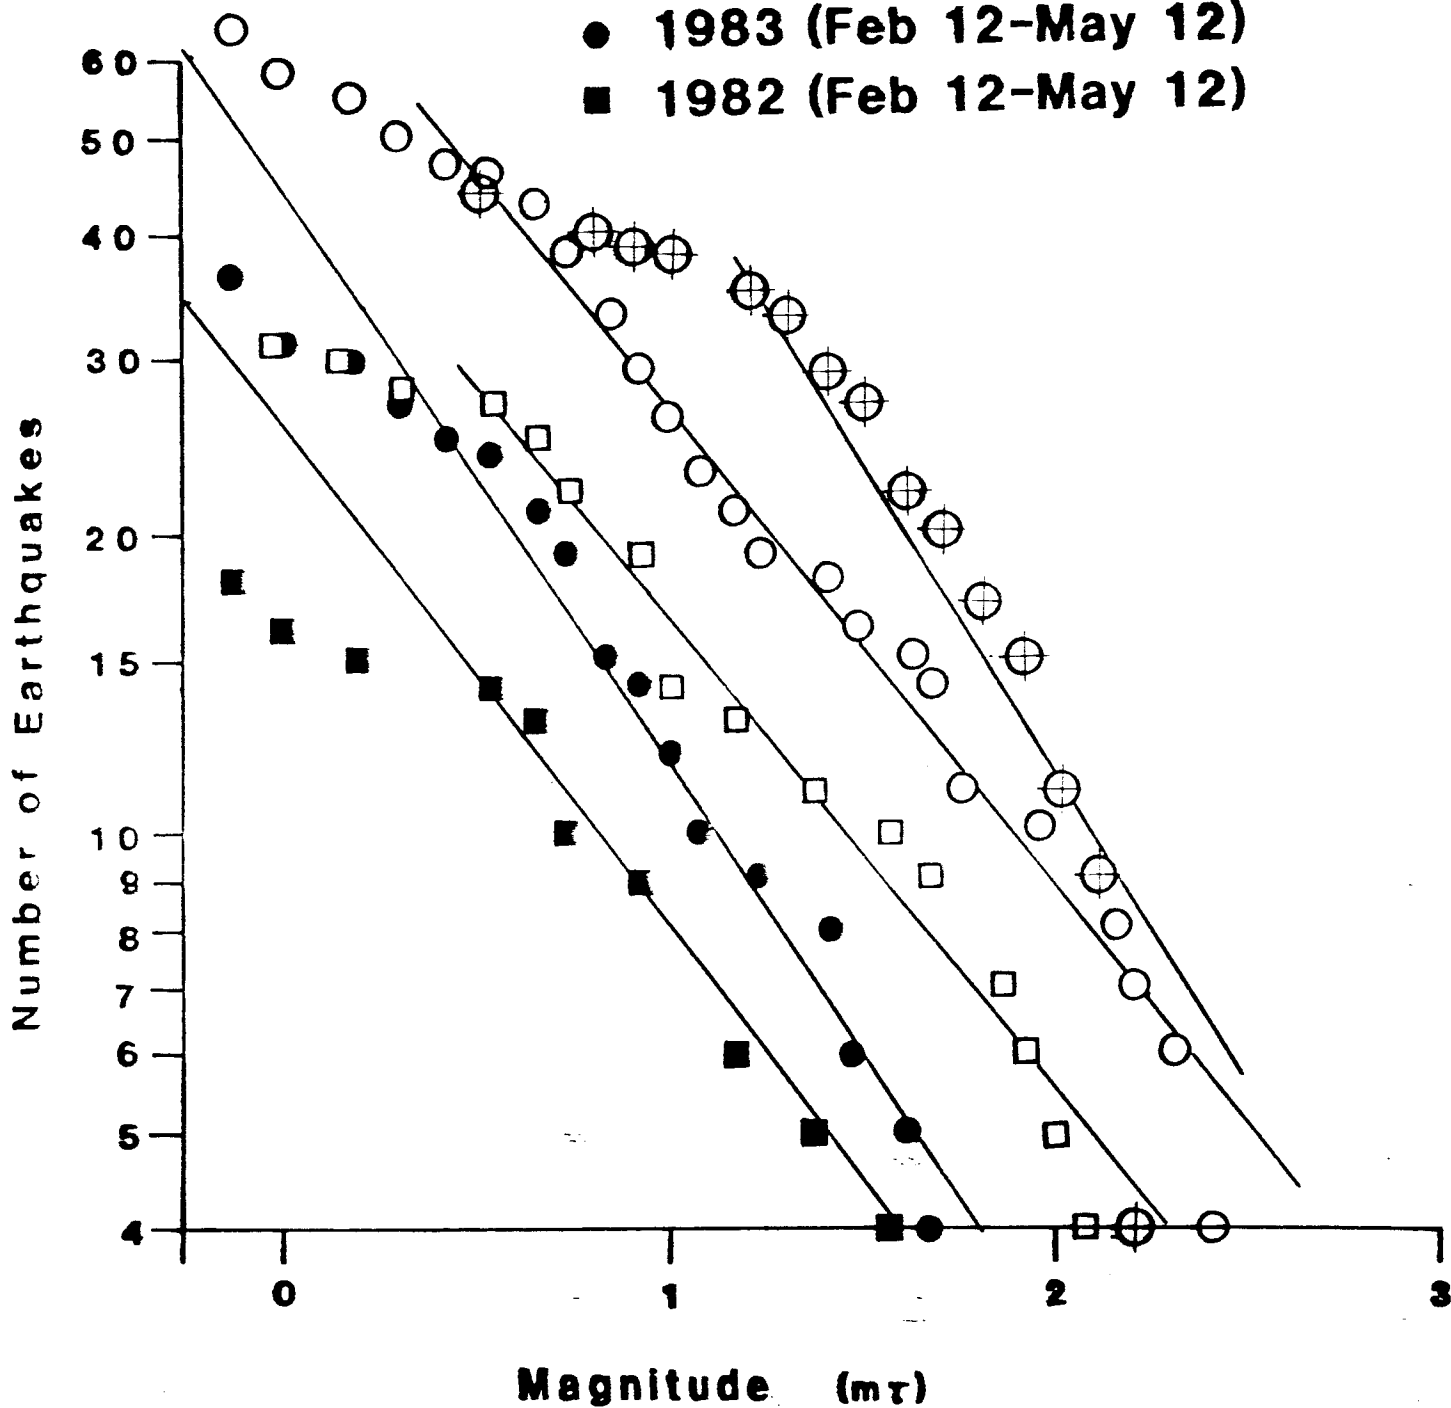
FIG 6A

To compare the level of seismic activity during the second half of loading, a similar relation was studied for the period from 13 May - 12 September 1983 (Figure 6A) and is listed as follows:

$$\log N = 2.34 - 0.63 M \text{ (within 32 km radius, 13 May-12 Sept. 1983)} \quad (5)$$

$$\log N = 2.21 - 0.63 M \text{ (same as equation (5), normalized to 3 month period)} \quad (6)$$

The slope (b-value) of the number-magnitude relation for equation (6) is greater than any of the previous equations. This means that the increase of smaller events is more significant than those of larger events.

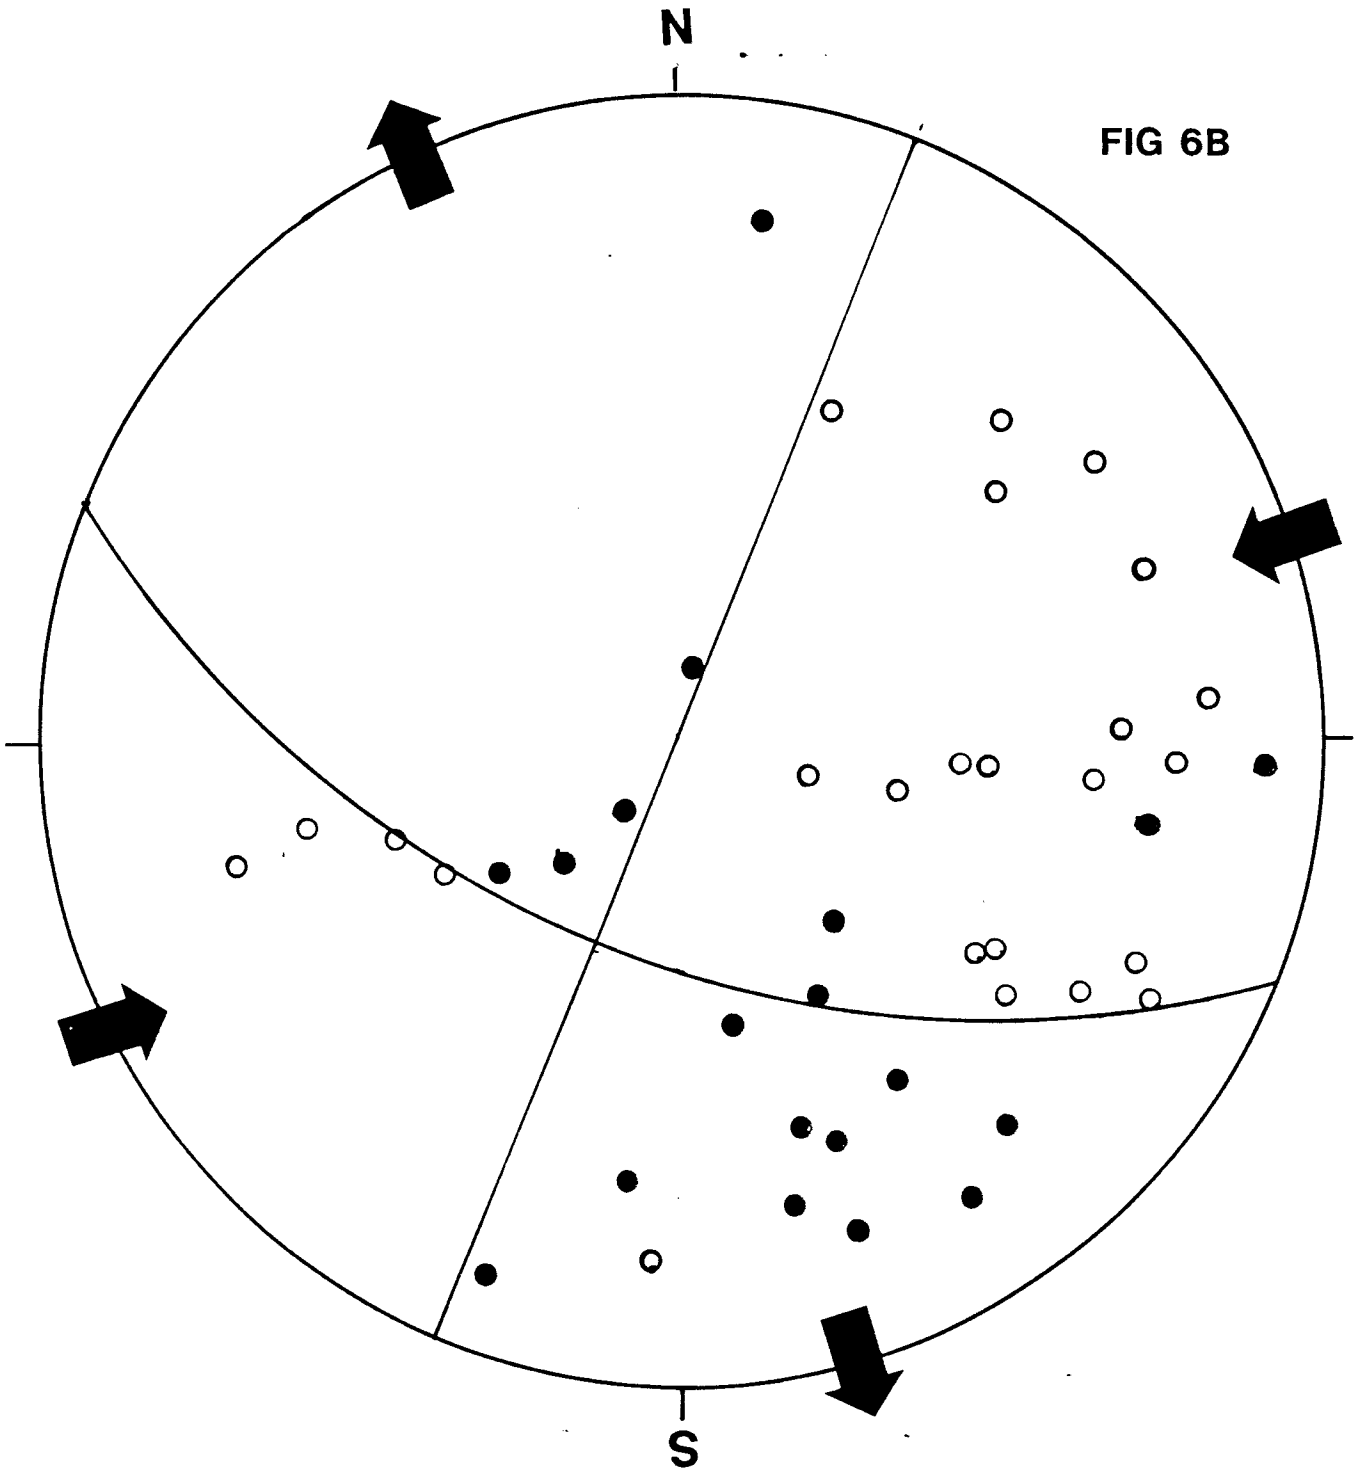
FIG 6B

The composite fault plane solutions for the events distributed along the Cuilco-Chixoy-Polochic fault were studied and shown in Figure 6B.

As contrasted to the fault plane solutions for earthquakes located near the dam site (Figure 2B), one of the fault planes shown in Figure 6B is almost parallel to east-west trending CCP fault. It is not known whether an increase of pore pressure would trigger a major earthquake along CCP fault or not.

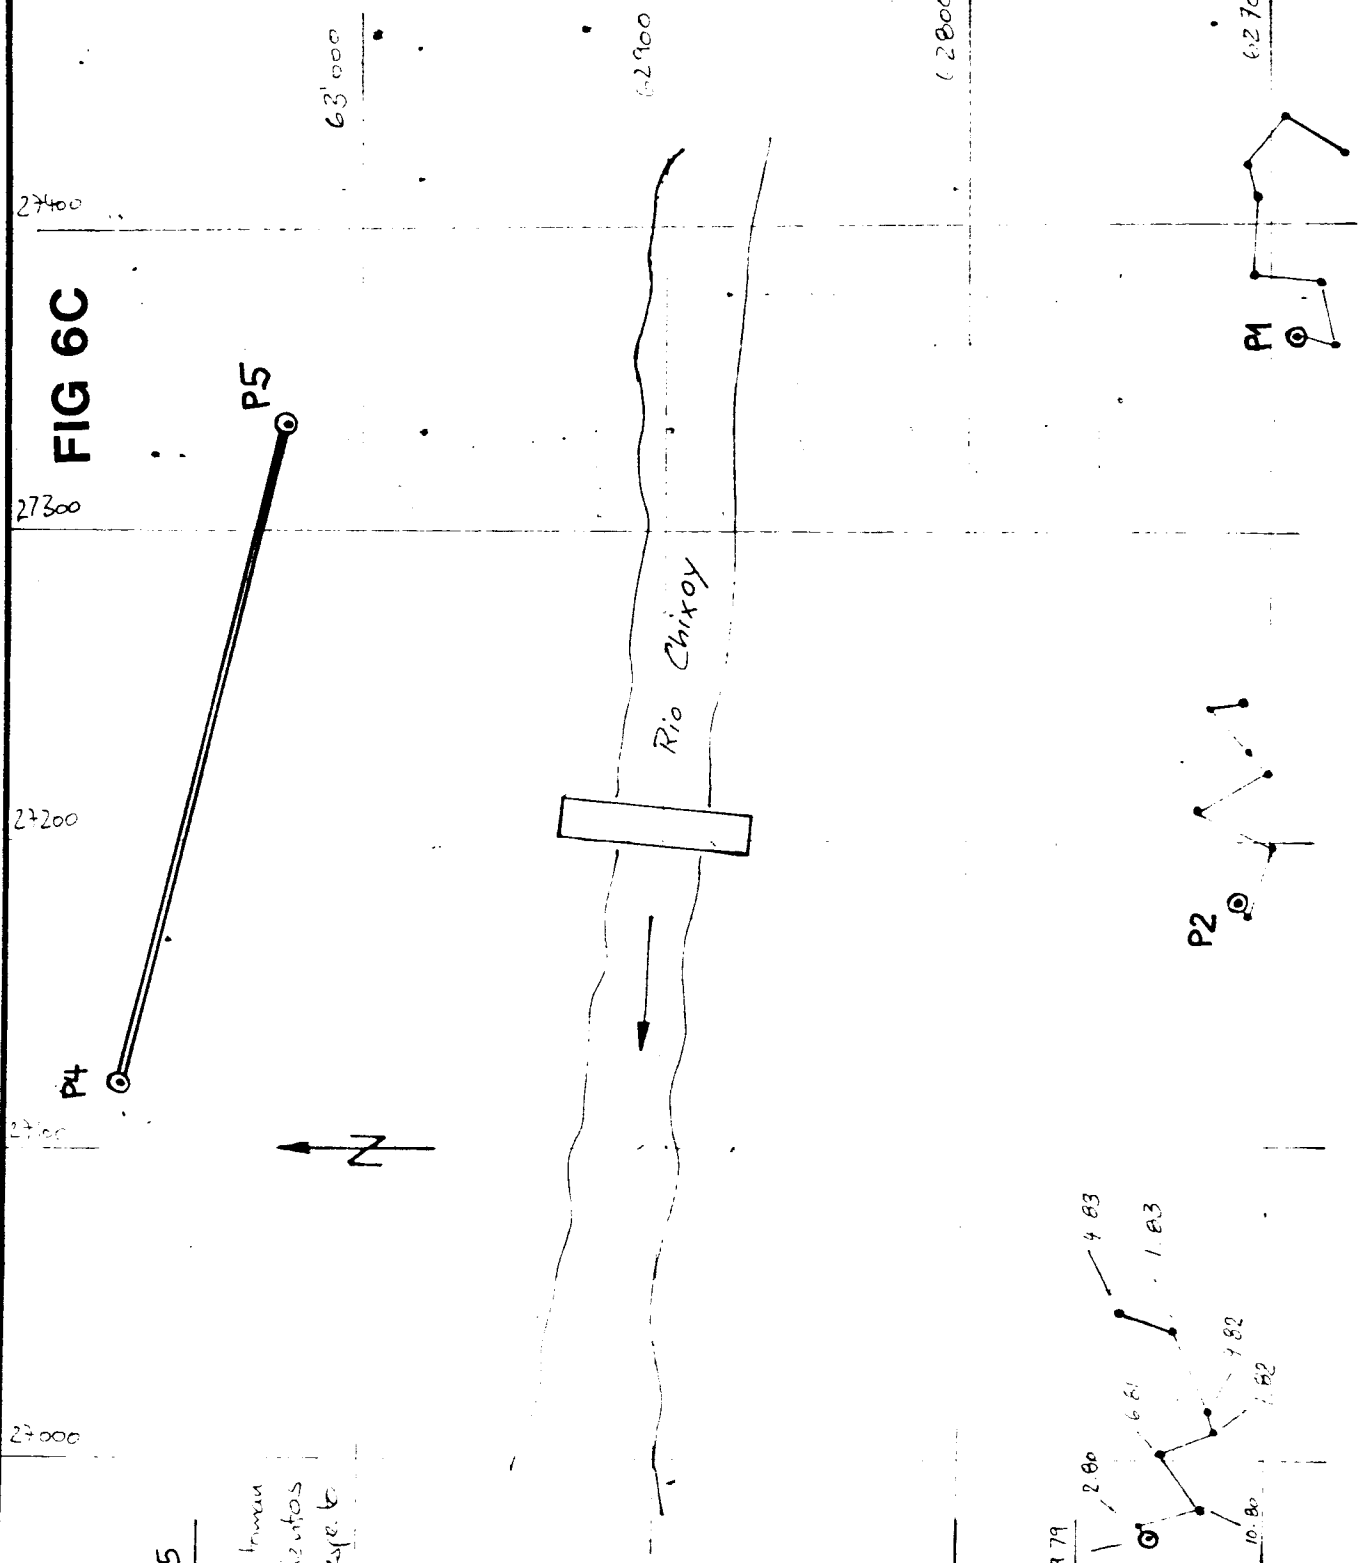
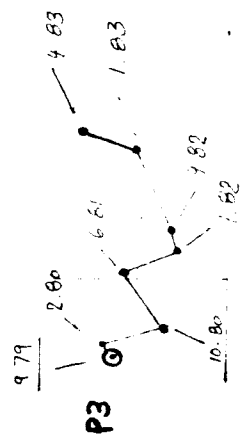
FIG 6C

**AGUA BLANCA
SISTEMA DE PILARES P1-P5**

Suposición: Los pilares P4, P5 se tienen como fijos. Se calculan movimientos RELATIVOS del lado sur con respecto al lado norte.

Sonsorio Lami generously provided important information on the movement of the CCP fault (Figure 6C). The triangulation of the bench marks across the fault has been carried out since September 1979. During the 44 month period, the average left-lateral movement of the bench marks were estimated at 0.73 cm/yr. Jordan (1975) indicated that the relative motion of the Caribbean-North American plates is at the rate of 2.2 cm/yr. Therefore, the movement of the CCP fault is taking up about 1/3 of the motion between the Caribbean and North American plates.

- 7.4 Triangulation survey of bench marks across the CCP fault should be repeated more frequently. Measurement at monthly or bi-monthly intervals is recommended.
- 7.5 Rapid draw-down from reservoir creates circumstances to trigger water-induced earthquakes for strike-slip environment. Due to the existence of Chixoy-Polochic fault, it is worthwhile to caution against rapid draw-down from the Pueblo Chixoy reservoir.
