# UT-GOM2-1-H005-1FB

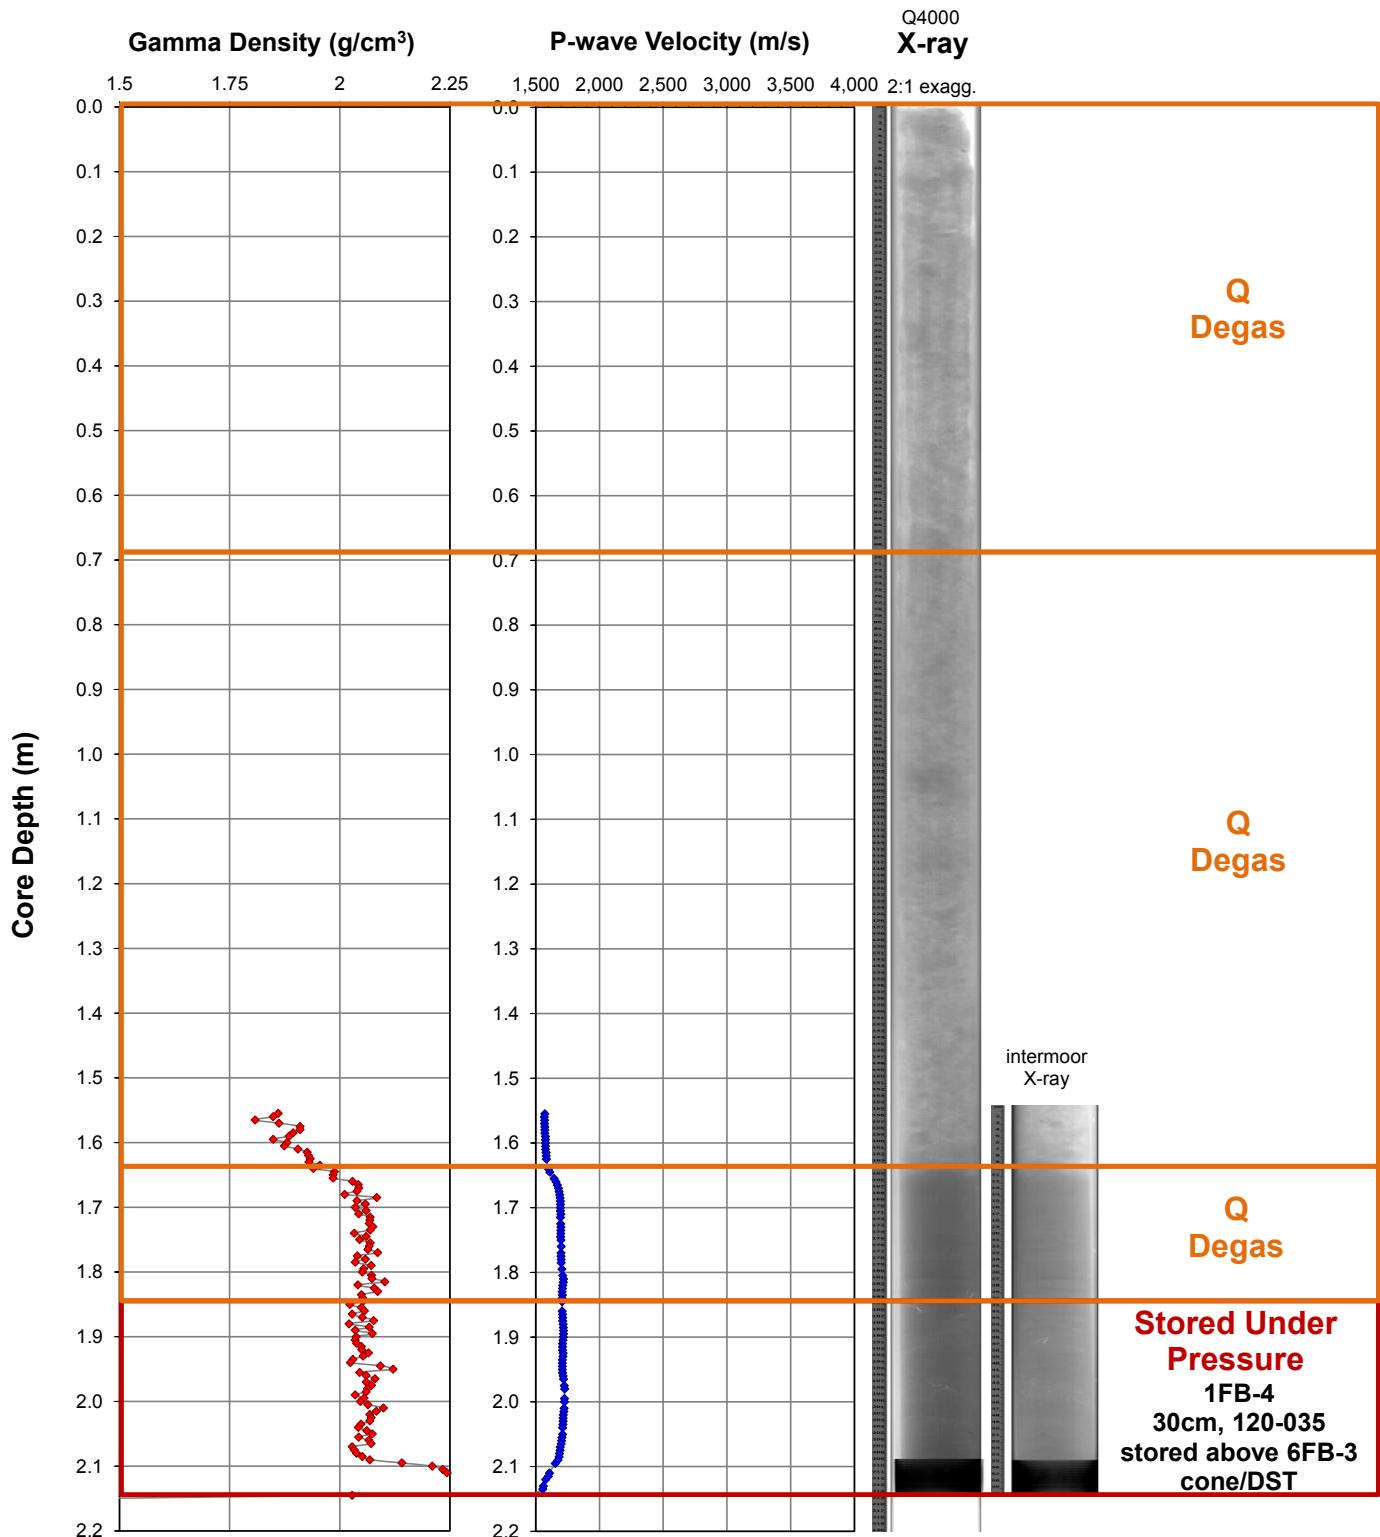
as cut

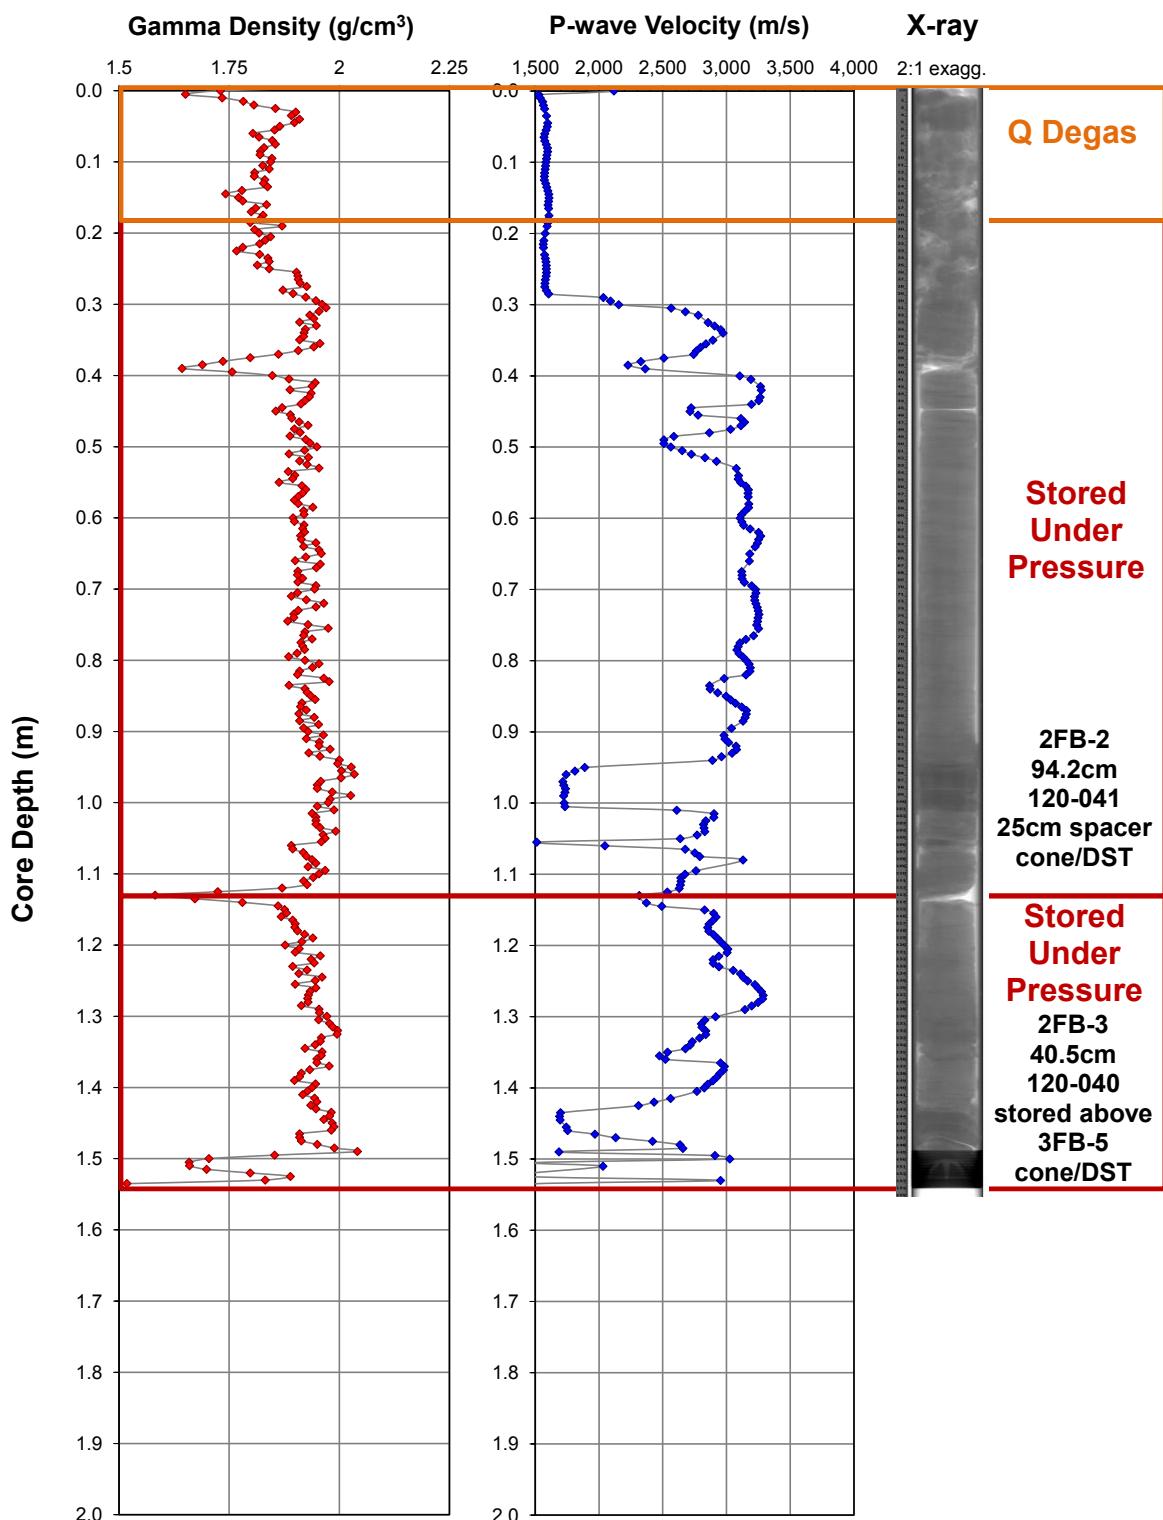
# UT-GOM2-1-H005-2FB

as cut

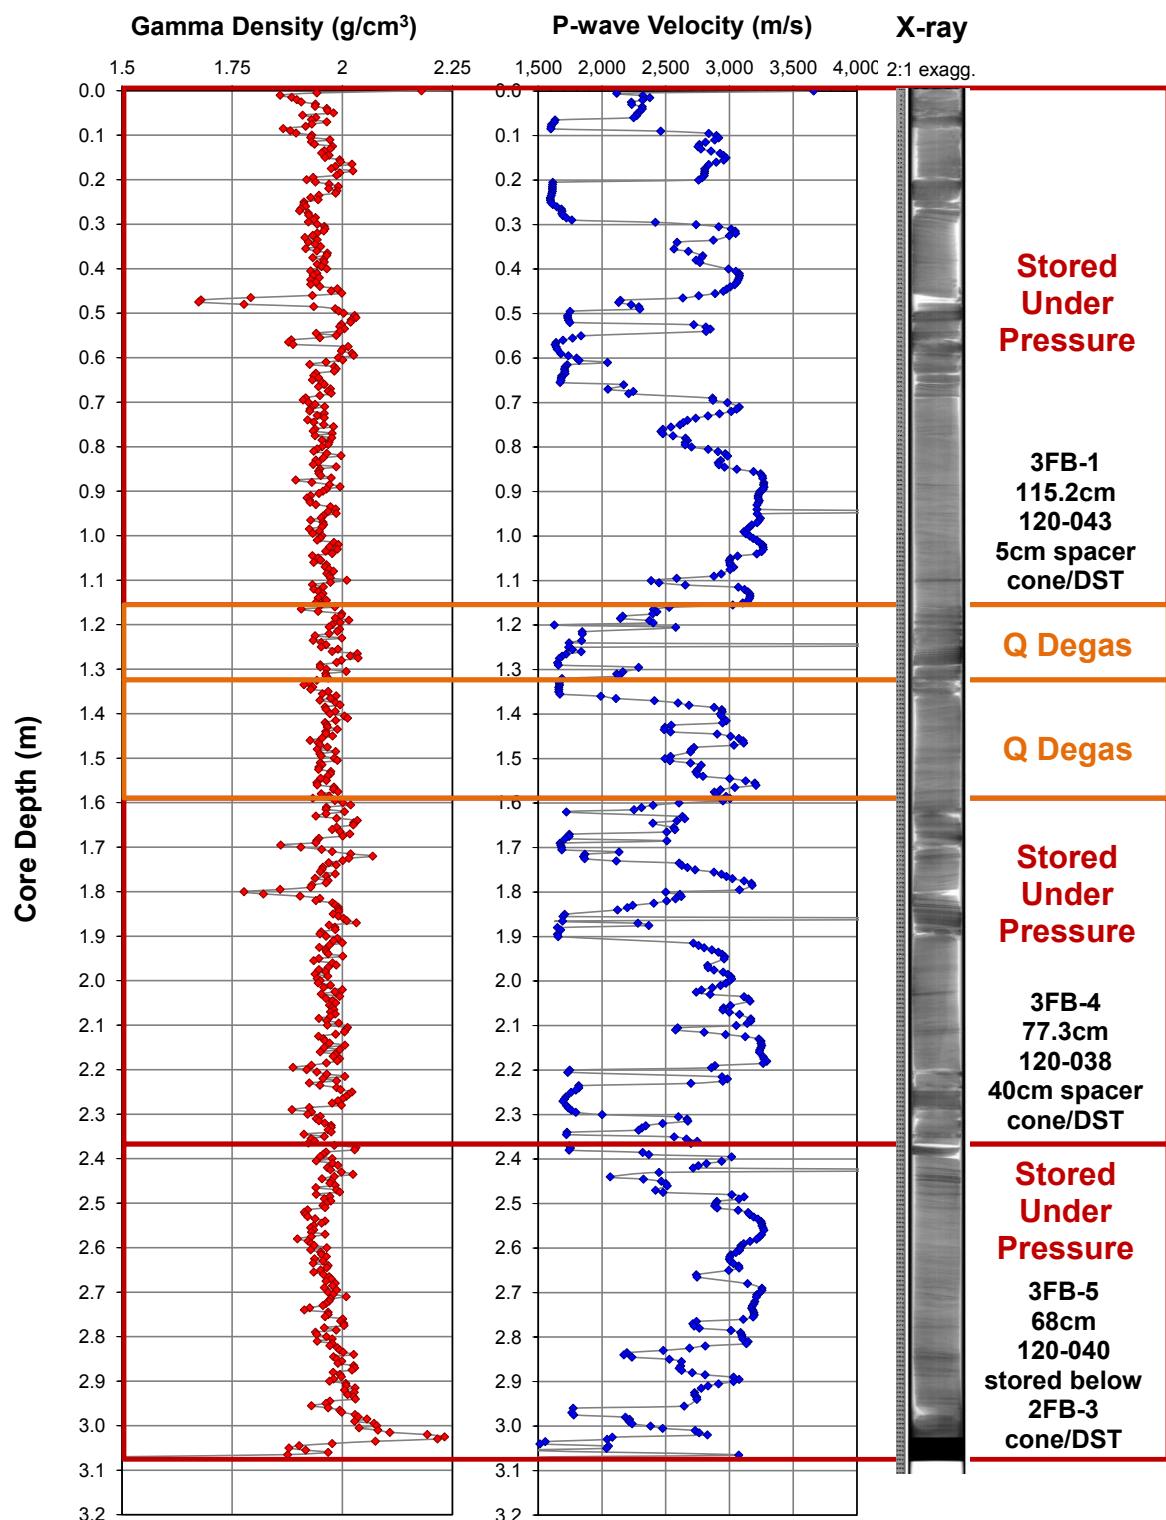
# UT-GOM2-1-H005-3FB

as cut

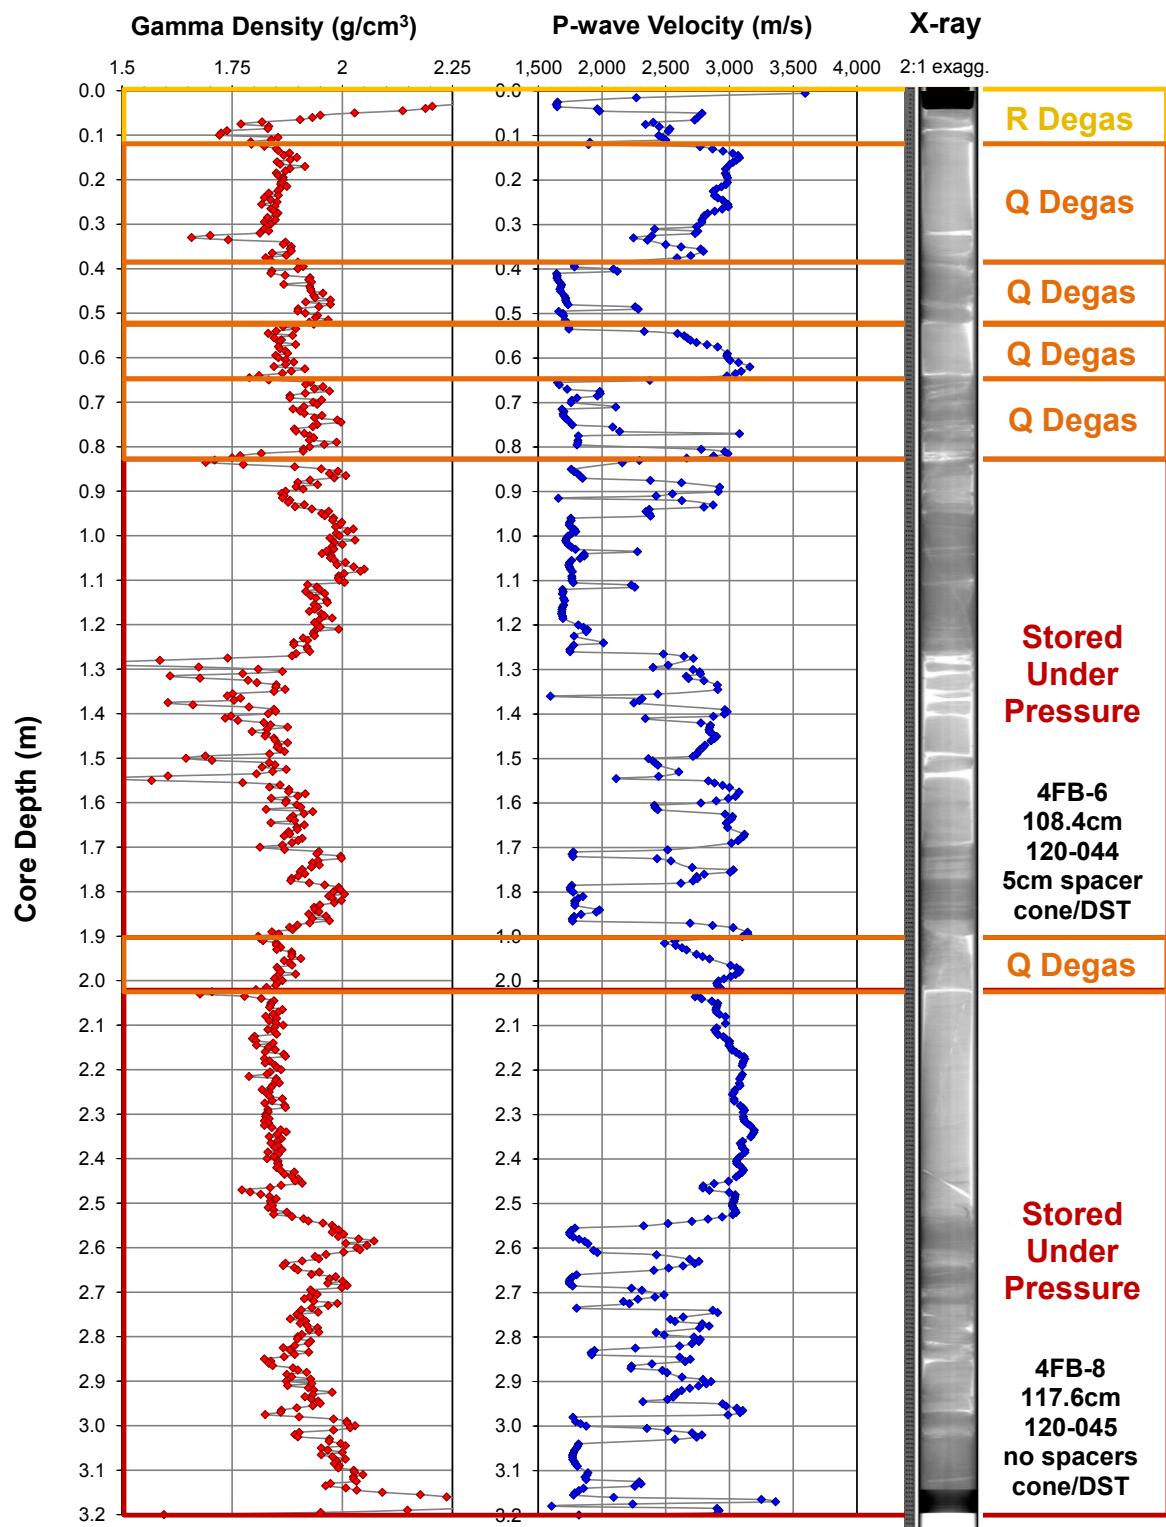
# UT-GOM2-1-H005-4FB

as cut

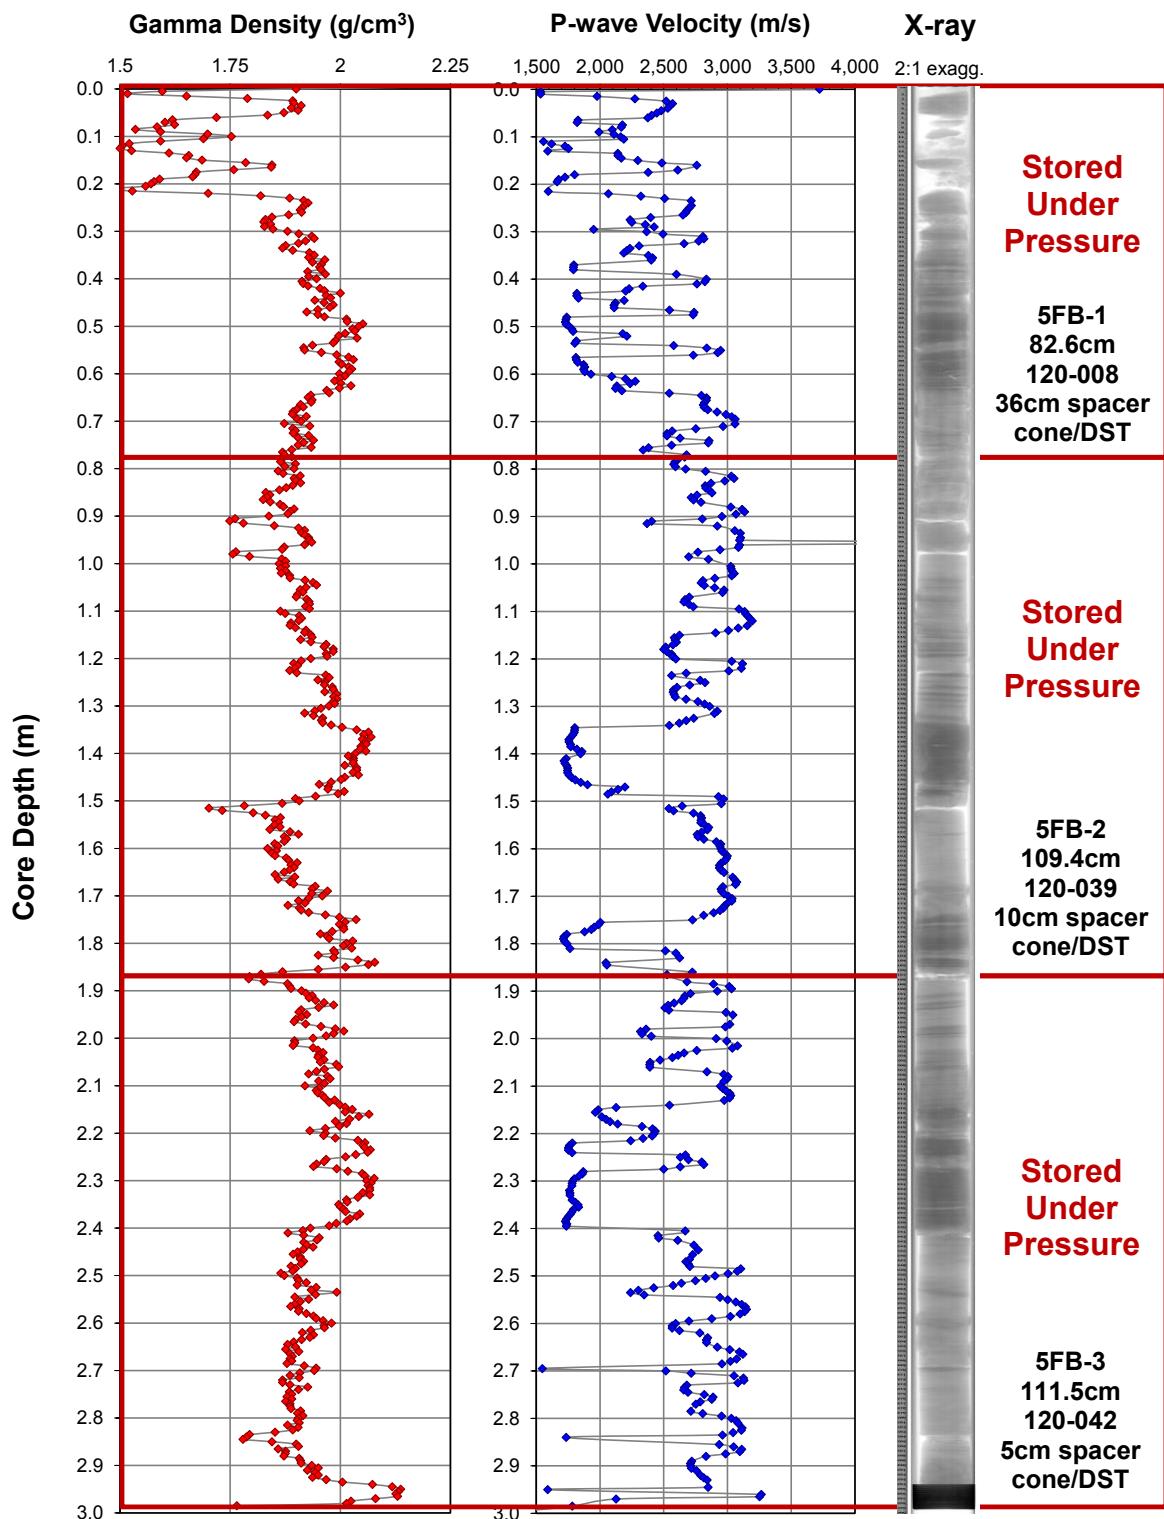
# UT-GOM2-1-H005-5FB

as cut

liner lengths do not match scan as core moved during cuts

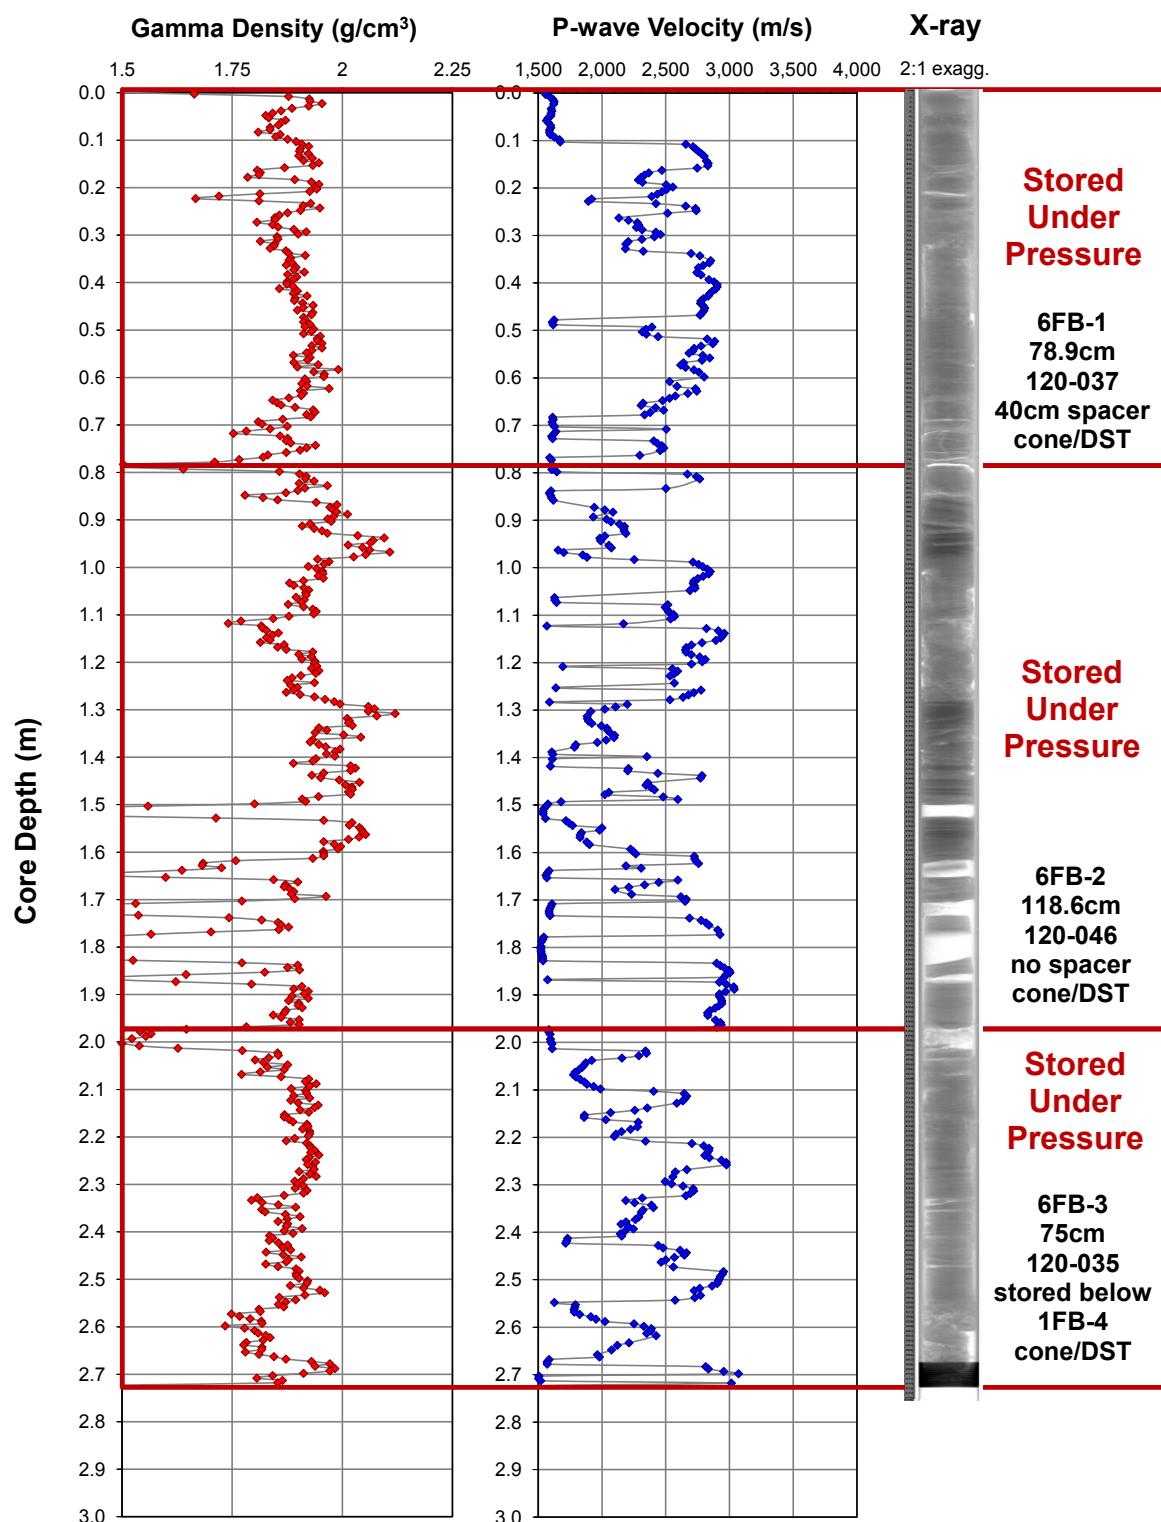
# UT-GOM2-1-H005-6FB

as cut

scanned again after temporary pressure drop

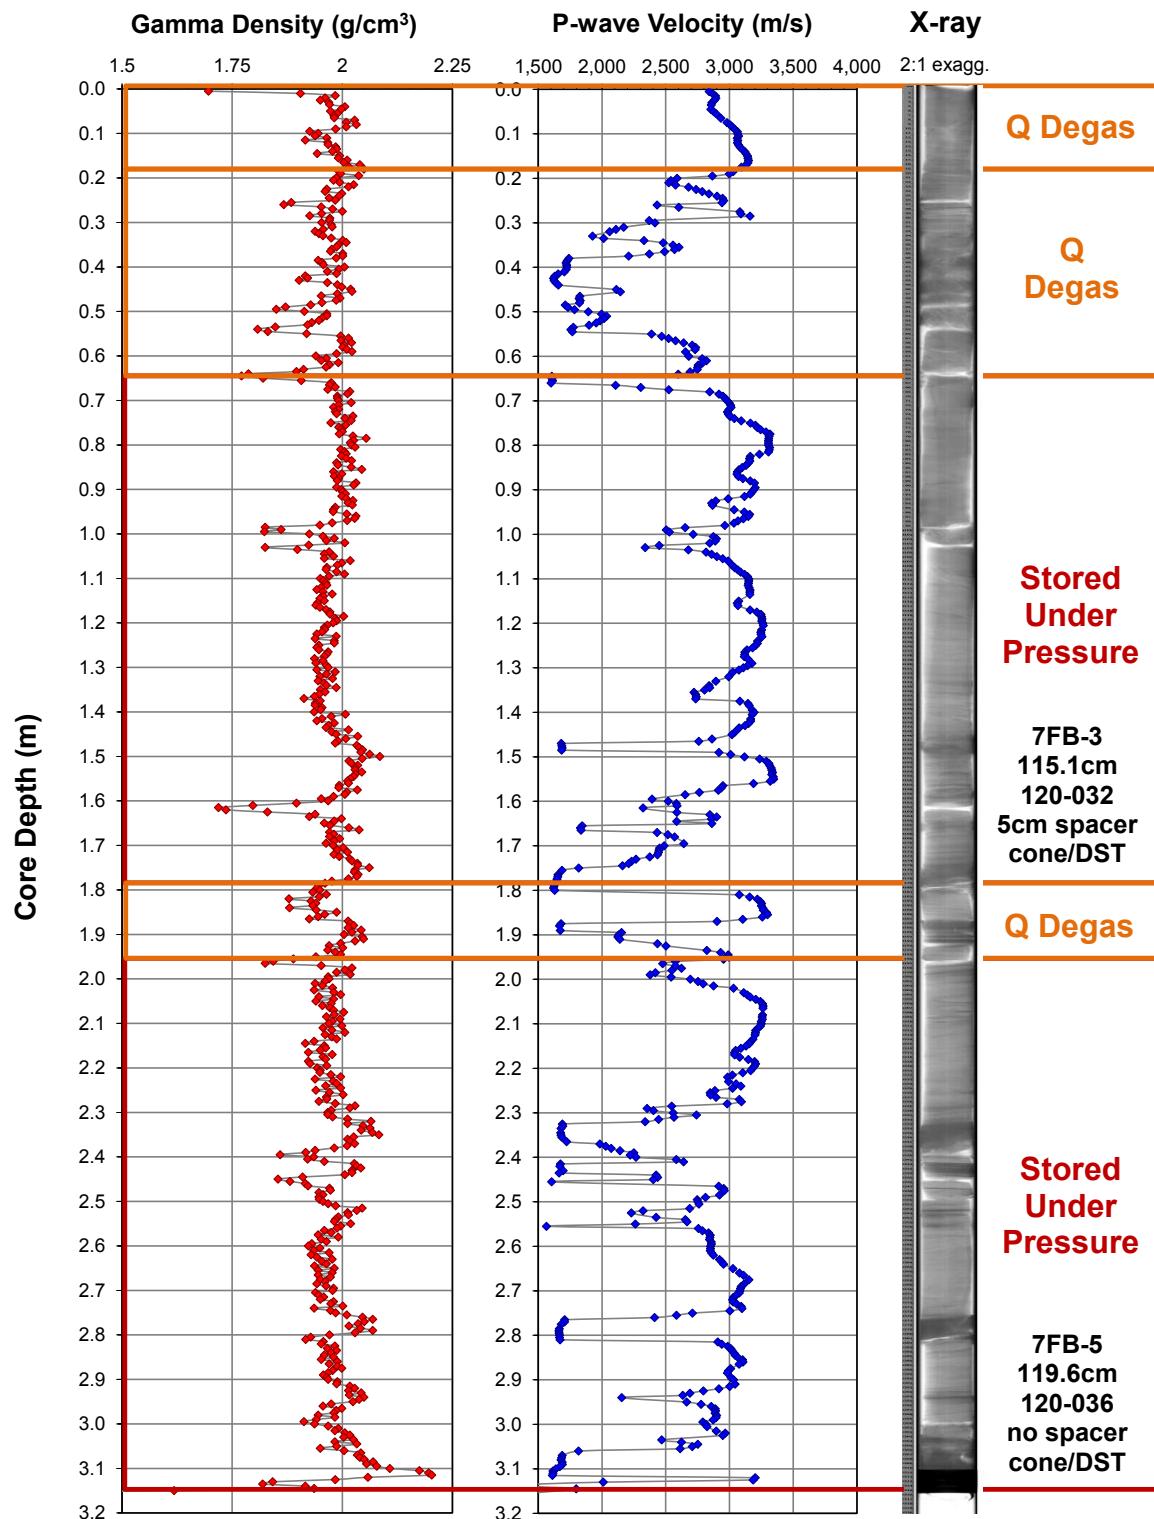
# UT-GOM2-1-H005-7FB

as cut

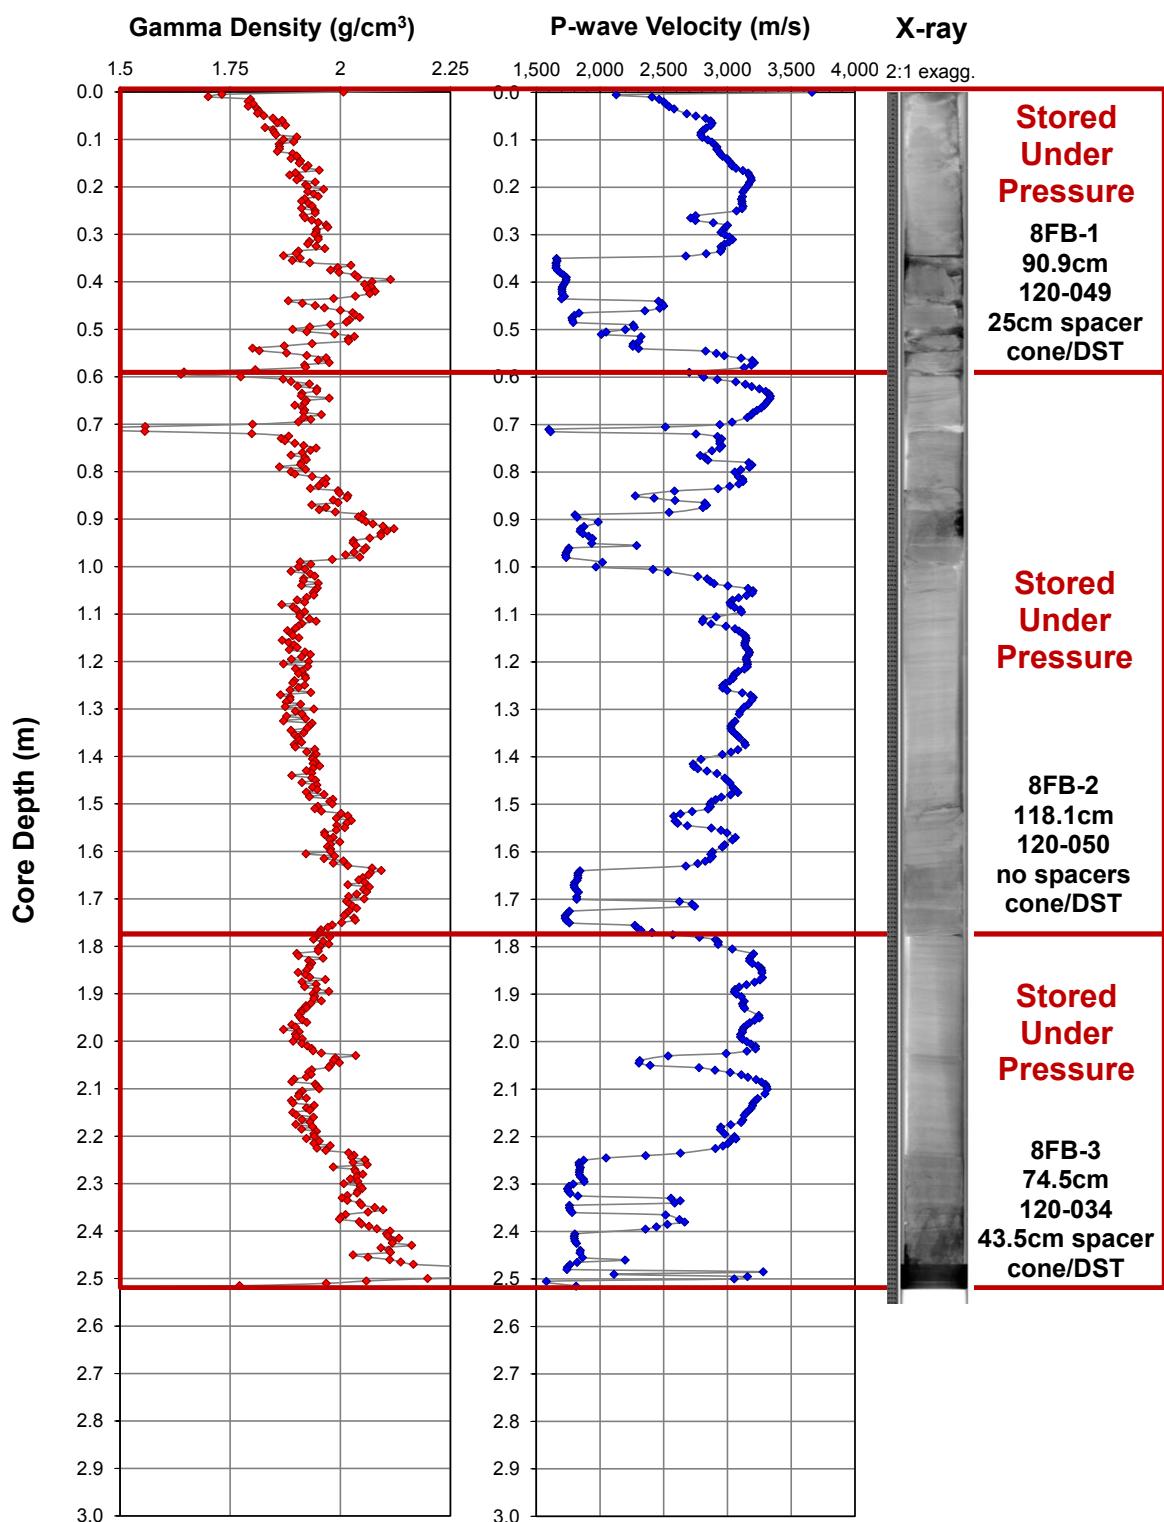
# UT-GOM2-1-H005-8FB

as cut

liner lengths do not match scan as core moved during cuts

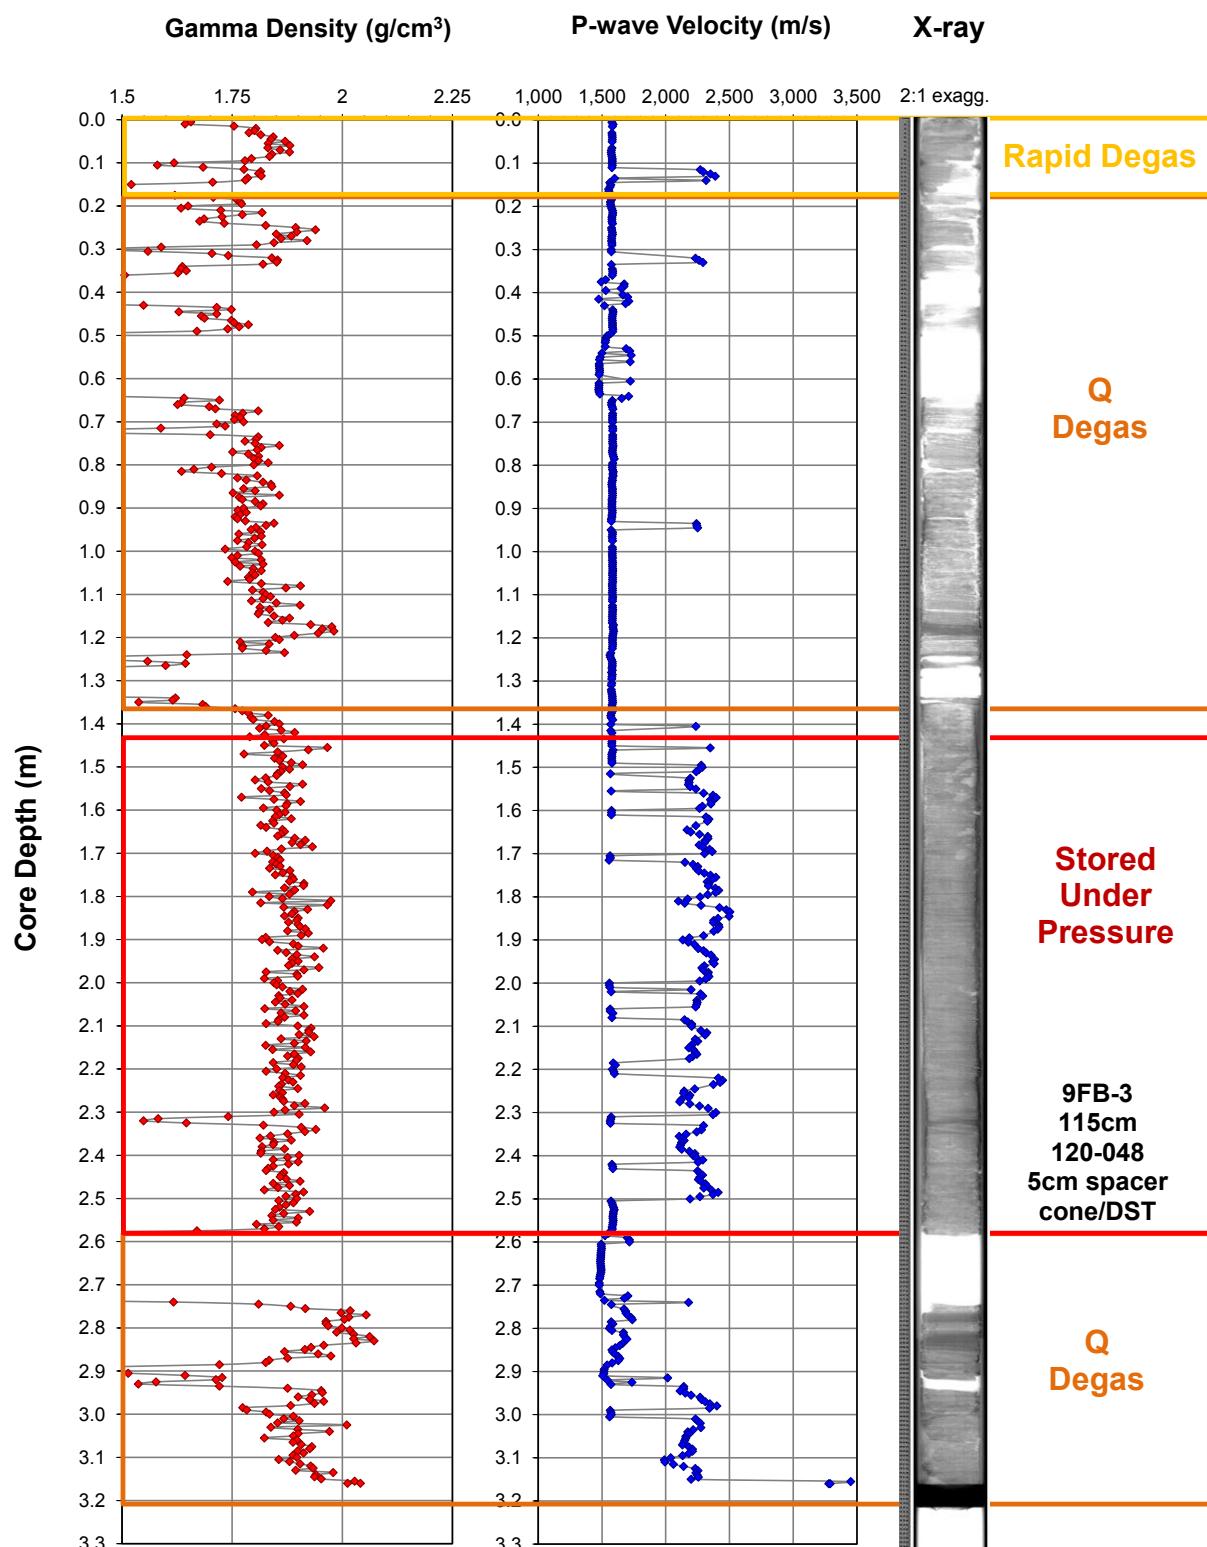
# UT-GOM2-1-H005-9FB

as cut (Q4000 data)

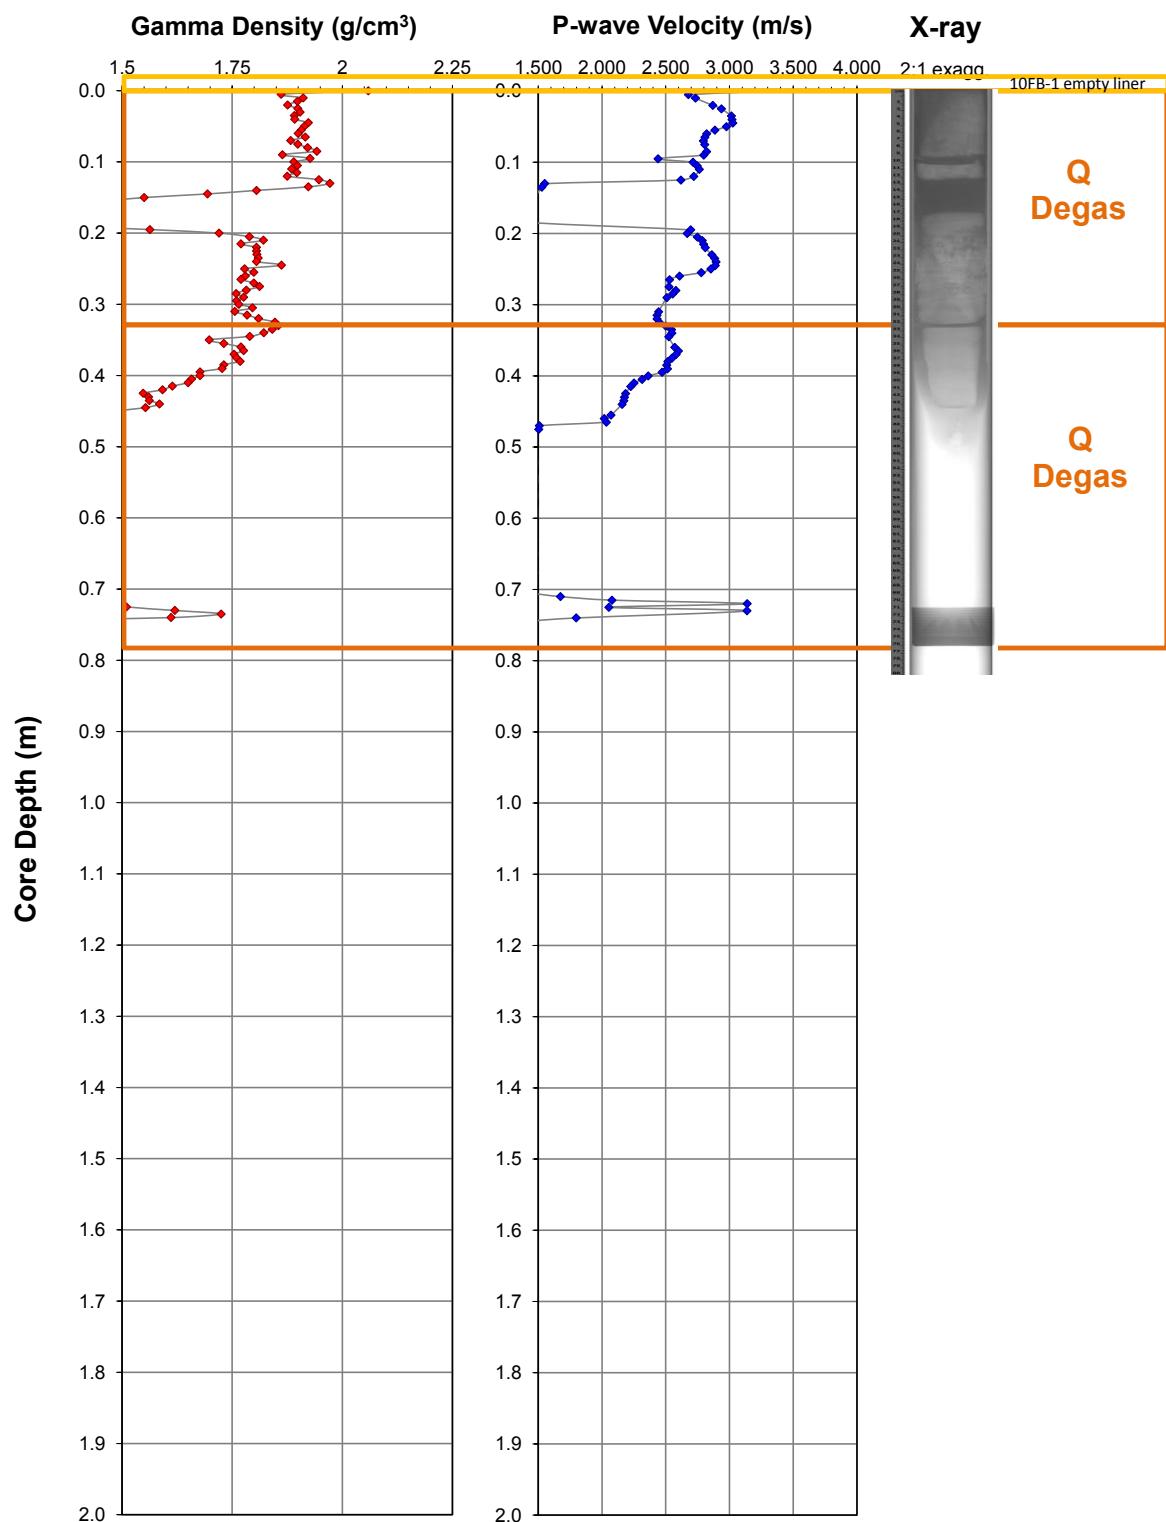
# UT-GOM2-1-H005-10FB

as cut

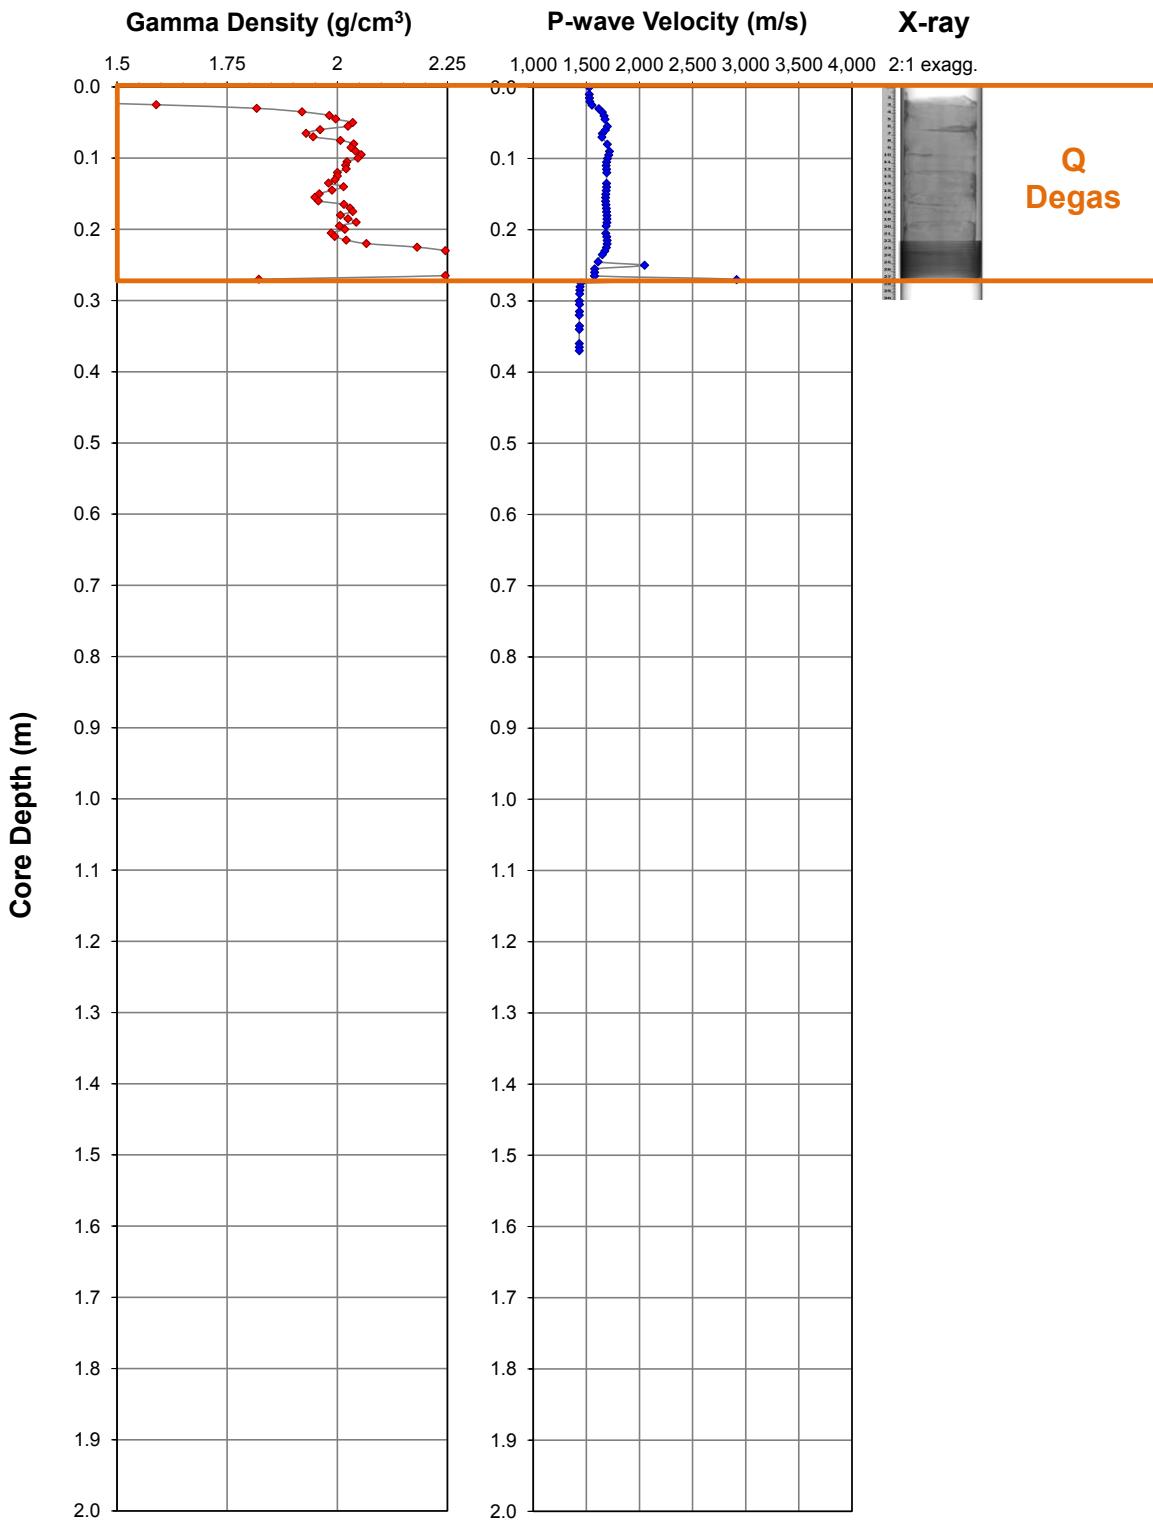
# UT-GOM2-1-H005-11FB

as cut

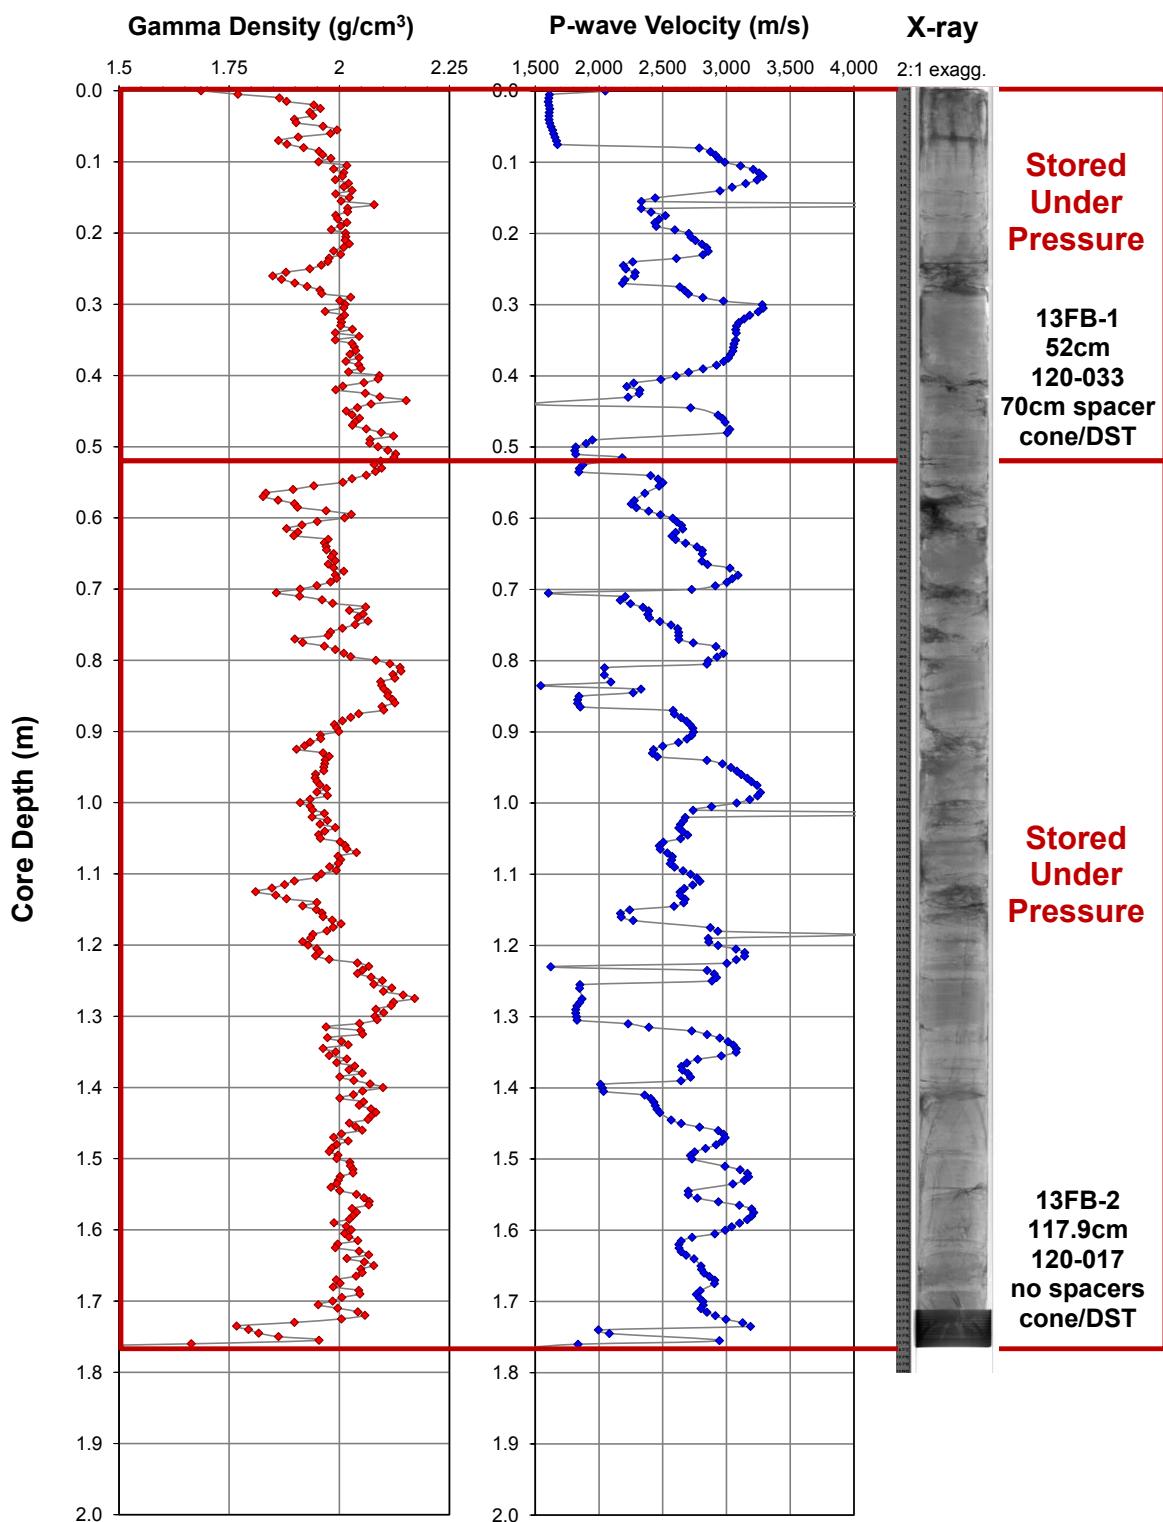
# UT-GOM2-1-H005-13FB

as cut
